Upper Truckee Marsh Sewer Facilities Protection Project Adaptive Management Plan Closeout Report

February 9, 2022 Final Report

South Tahoe Public Utility District 1275 Meadow Crest Drive South Lake Tahoe, CA 96150 Final Report February 2022

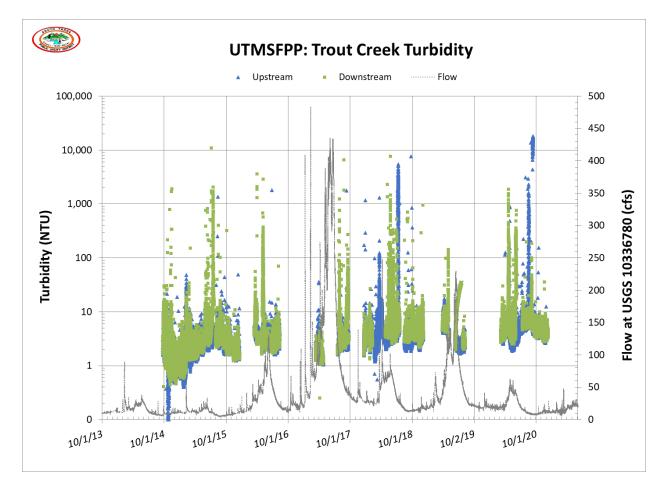
Figure 4-5 shows the turbidity measurements upstream and downstream of the work area near Bellevue Avenue for the duration of the project from 2014 to 2020. The records indicate no long-term trend for elevated turbidity at the downstream gage compared to the upstream location. In addition, no temporary impacts associated with Year 3 construction in October 2017 are evident. Year 4 records are unfortunately intermittent and there is a gap during the period of maintenance activities in November 2017. Both Year 3 and Year 4 records show periods of spikes in downstream turbidity but the cause of these increases is unknown and does not correspond to periods of project activity. Although one purpose of the turbidity monitoring is to determine if the project activities from the previous year increase turbidity during high runoff periods, the observed spikes are not consistent with a general increase in erosion or sediment transport in the pilot channels. Turbidity in 2020 was similar to previous years, with perhaps a slight increase in turbidity (Figure 4-6). Outside of the periods with spikes in downstream turbidity, the plots generally show that turbidity is in the range of 2 to 10 NTUs, with a slight trend for higher levels during summer months.

Figure 4-5. Turbidity upstream and downstream of work area near Bellevue Avenue.

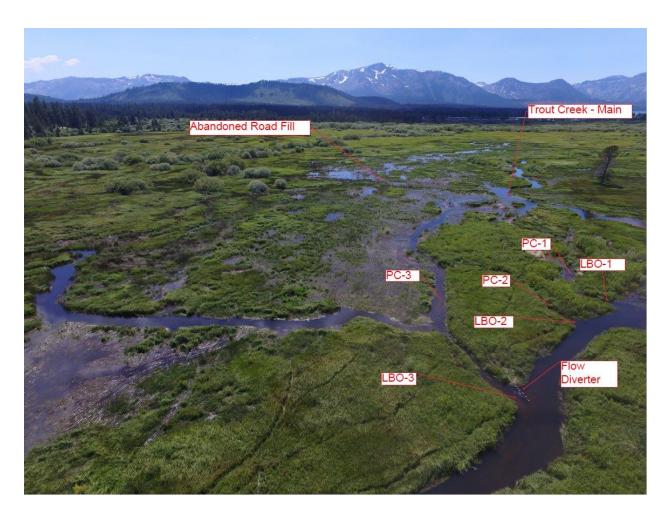
Figure 4-16. Annotated aerial imagery looking downstream across project site, photo taken 28 July 2017 (STPUD image).

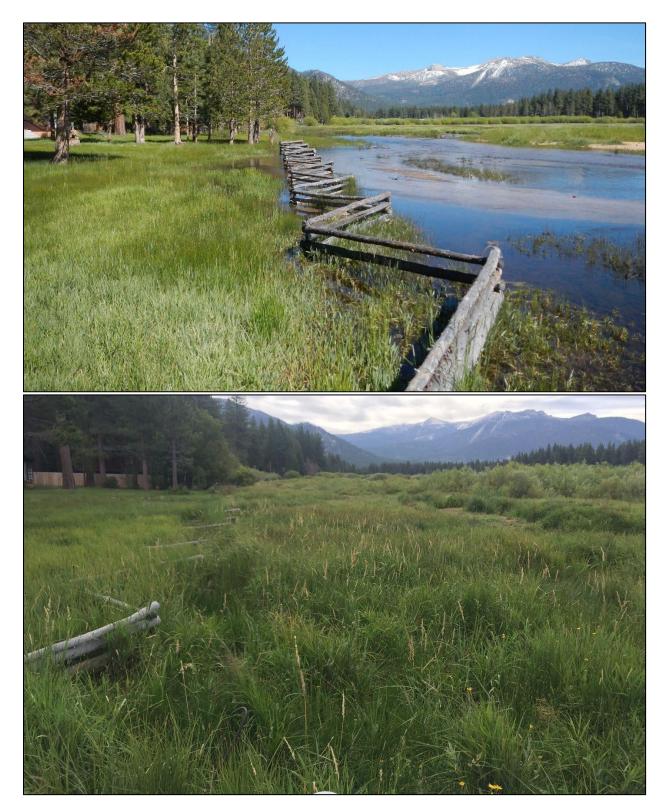
Figure 5-1. Easement conditions near Bellevue Avenue in May 2014 (top) and August 2019 (bottom), view looking upstream.

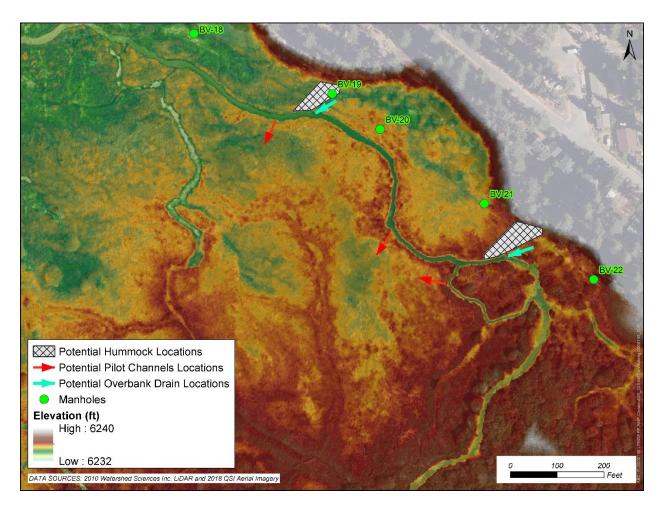
Figure 5-2. Conceptual potential remediation options for alleviating some inundation on the District's easement.

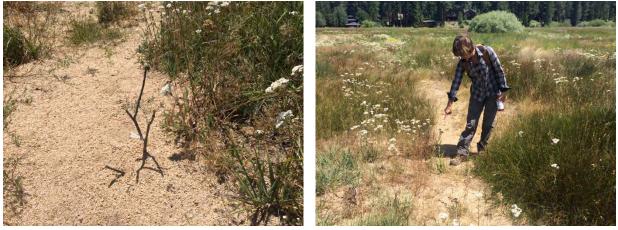
Photo 1. Improper material used for sausal.

Photo 2. Surviving stake in sausal.

The new hummock should be installed as soon as possible to maximize growth for this year. Additional willows are not necessary are the present time.

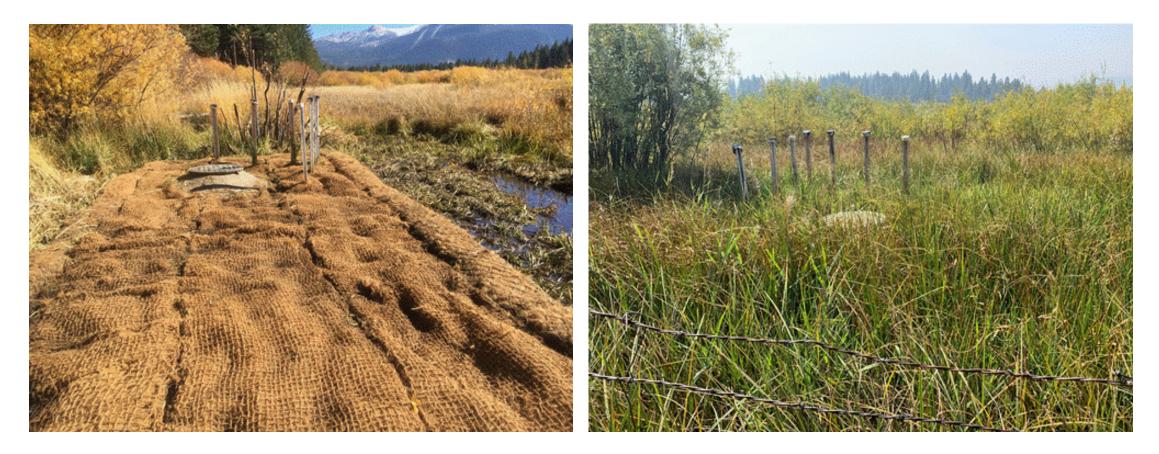
Photo 11. Hummock 6A, October 26, 2016

Photo 12. Hummock 6A, inundated, September 11, 2020

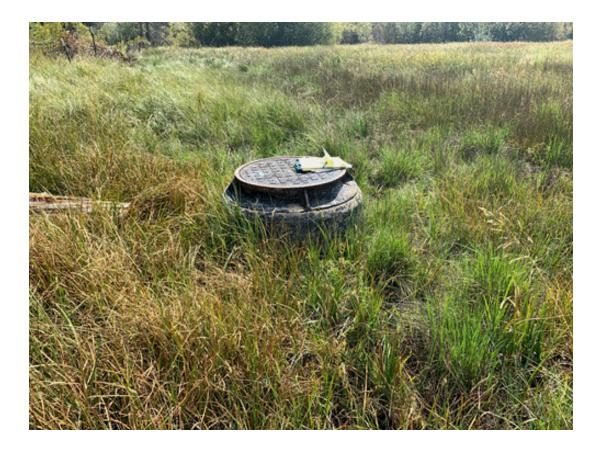
Photo 13. Hummock 7, September 11, 2020
