# South Upper Truckee Well Update

Mark Seelos  
Water Resources Manager  
12/21/2023

# South Upper Truckee Well No. 3

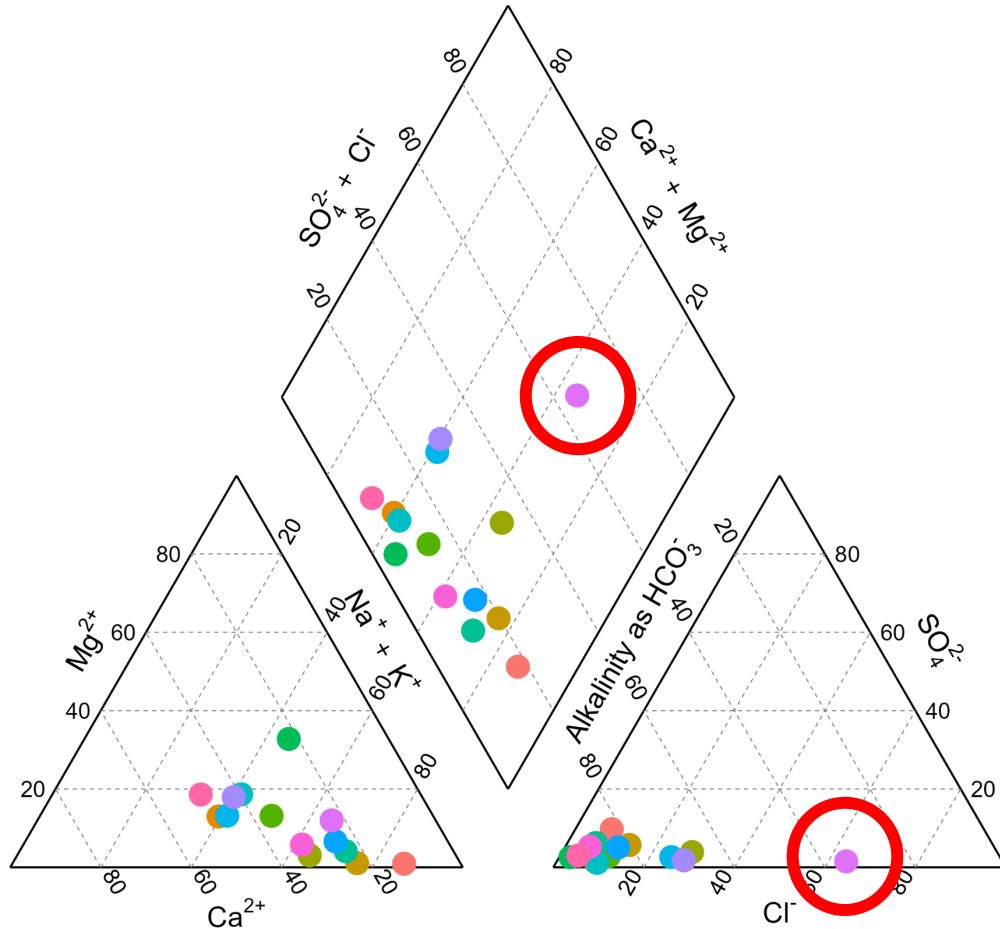
*A water quality anomaly...*

- Youngest and most problematic well.
- **Highly Corrosive**
  - pH ~6
  - Accelerated pitting corrosion of steel.
  - Wellhead treatment addresses some corrosivity in system.

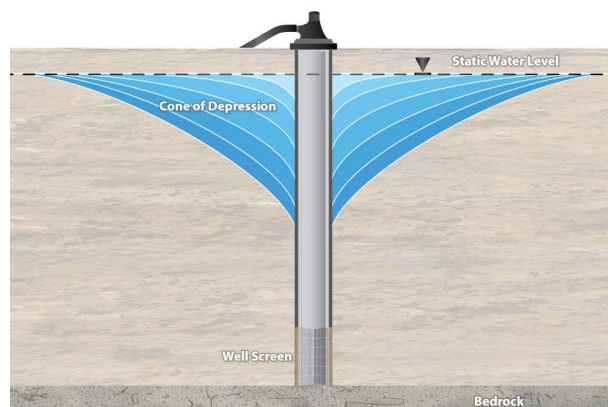
Specific Capacity: 7% Decline.

SC = GPM/ft of drawdown

Lost over 50 GPM/ft of drawdown.

- **>5% decline: Needs Maintenance**
- >15% decline: Needs Rehab

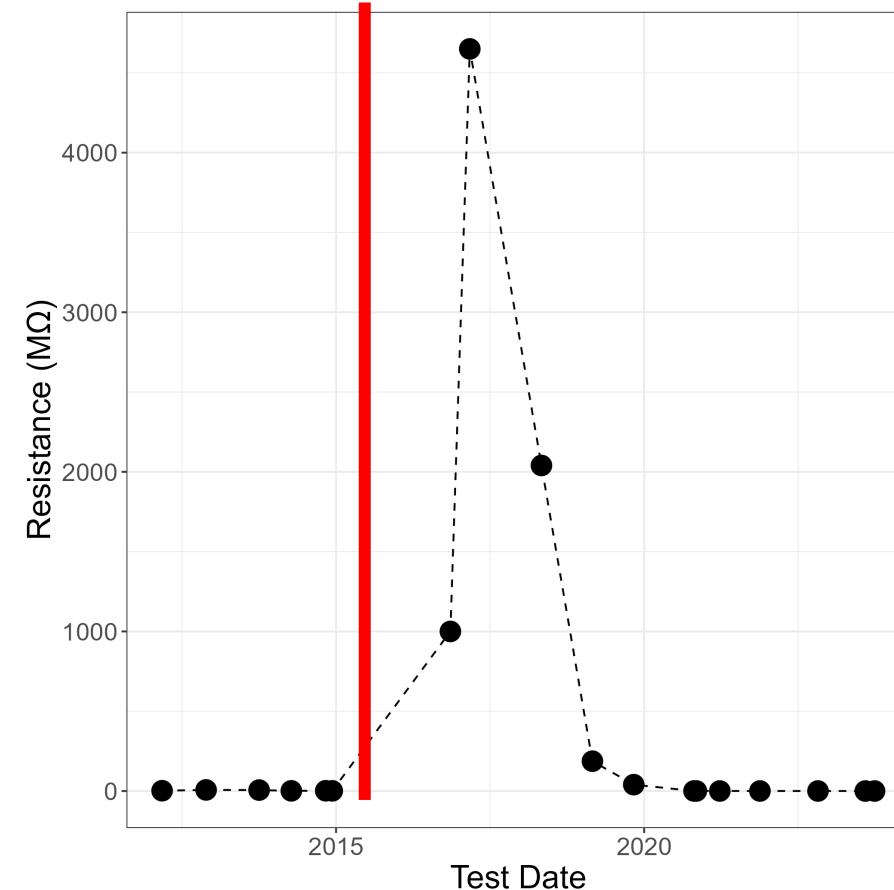
## Megger Testing (Electrical)

Pigtail Replaced

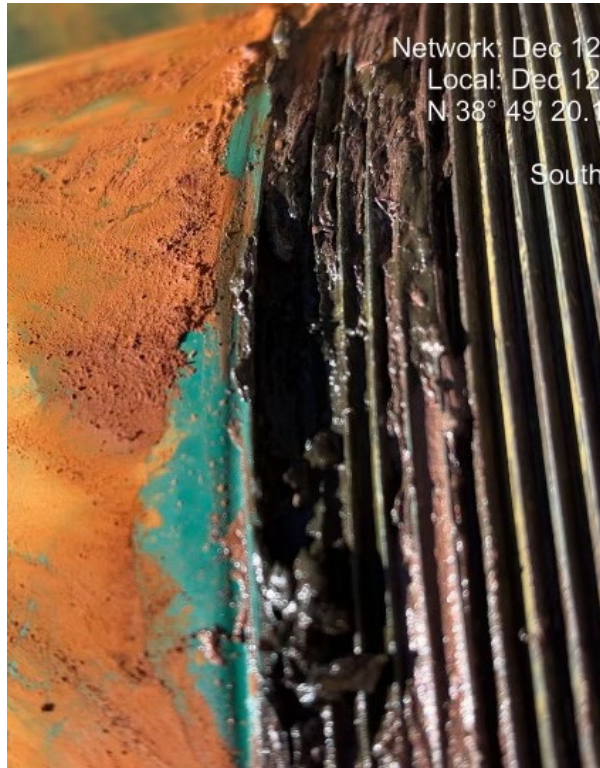
## Column Pipe

# Narrowly Avoided Failure

- Fiberglass or Stainless Steel
- Lead Time: Weeks to 2 Months

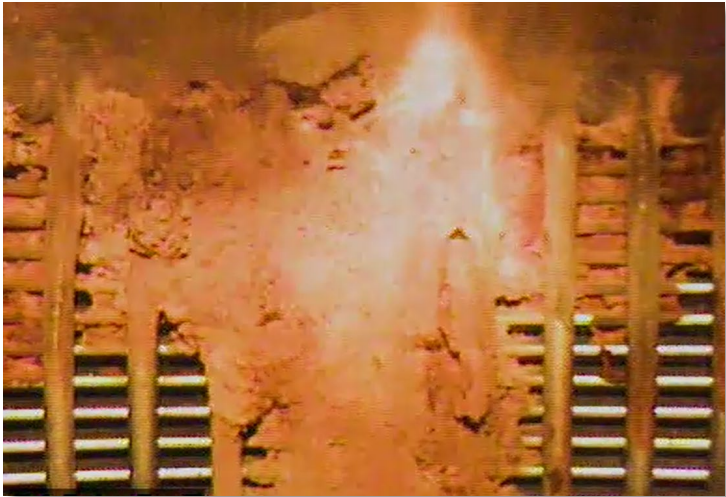
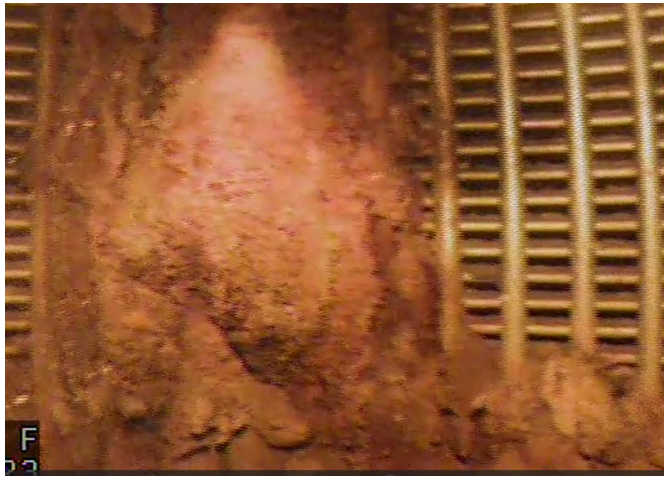
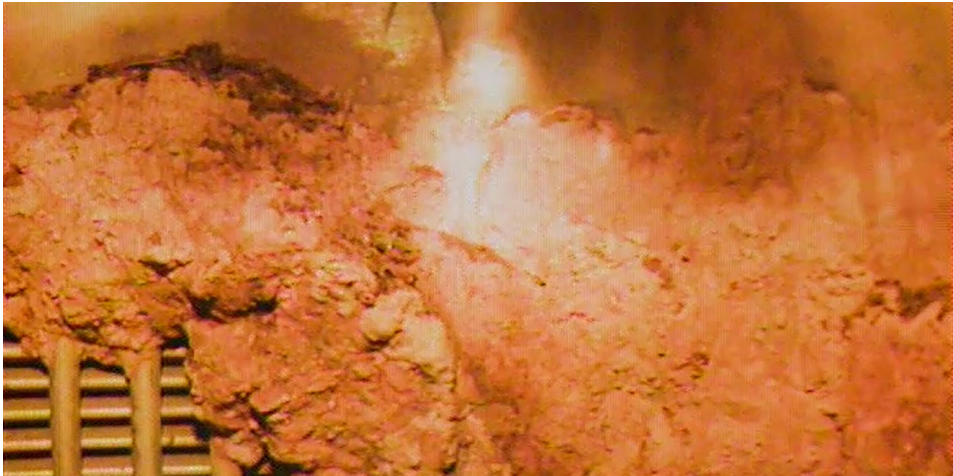
# CCTV: Extensive Tuberculation
