UPPER TRUCKEE MARSH SEWER FACILITIES ADAPTIVE MANAGEMENT PLAN

2017 ANNUAL REPORT

South Tahoe Public Utility District

Northwest Hydraulic Consultants Inc.

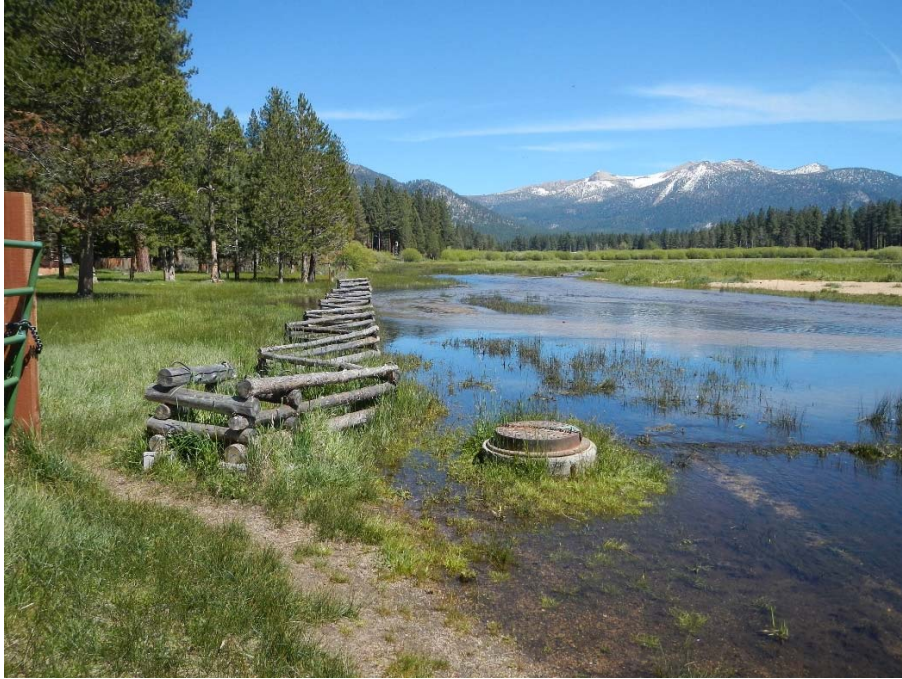
Figure 2-4. Inundation of the sewer easement near Bellevue Avenue at a flow of approximately 40 cfs, looking upstream, 20 May 2013

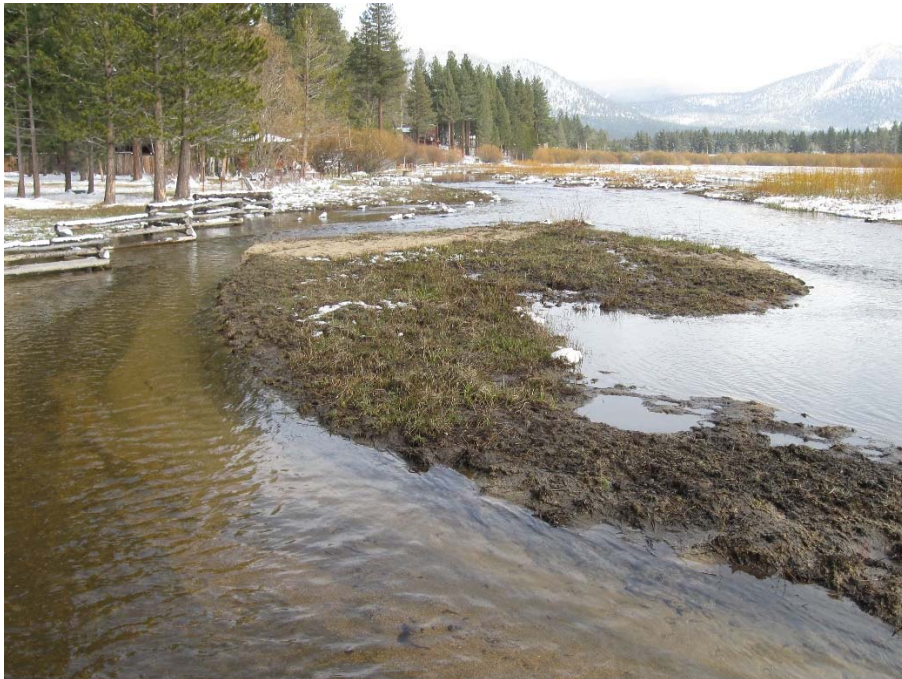
Figure 2-5. Inundation of the sewer easement near Bellevue Avenue at a flow of approximately 20 cfs, looking upstream, 1 Apr 2014

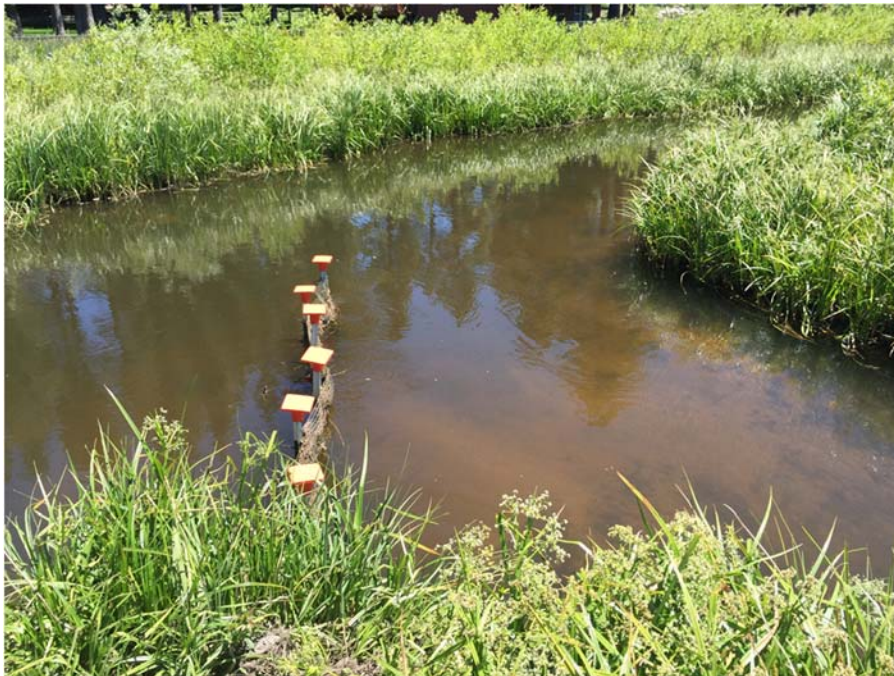
Figure 4-2. PC-3 flow diverter at head of PC-3; flow in PC-3 is towards lower right of frame

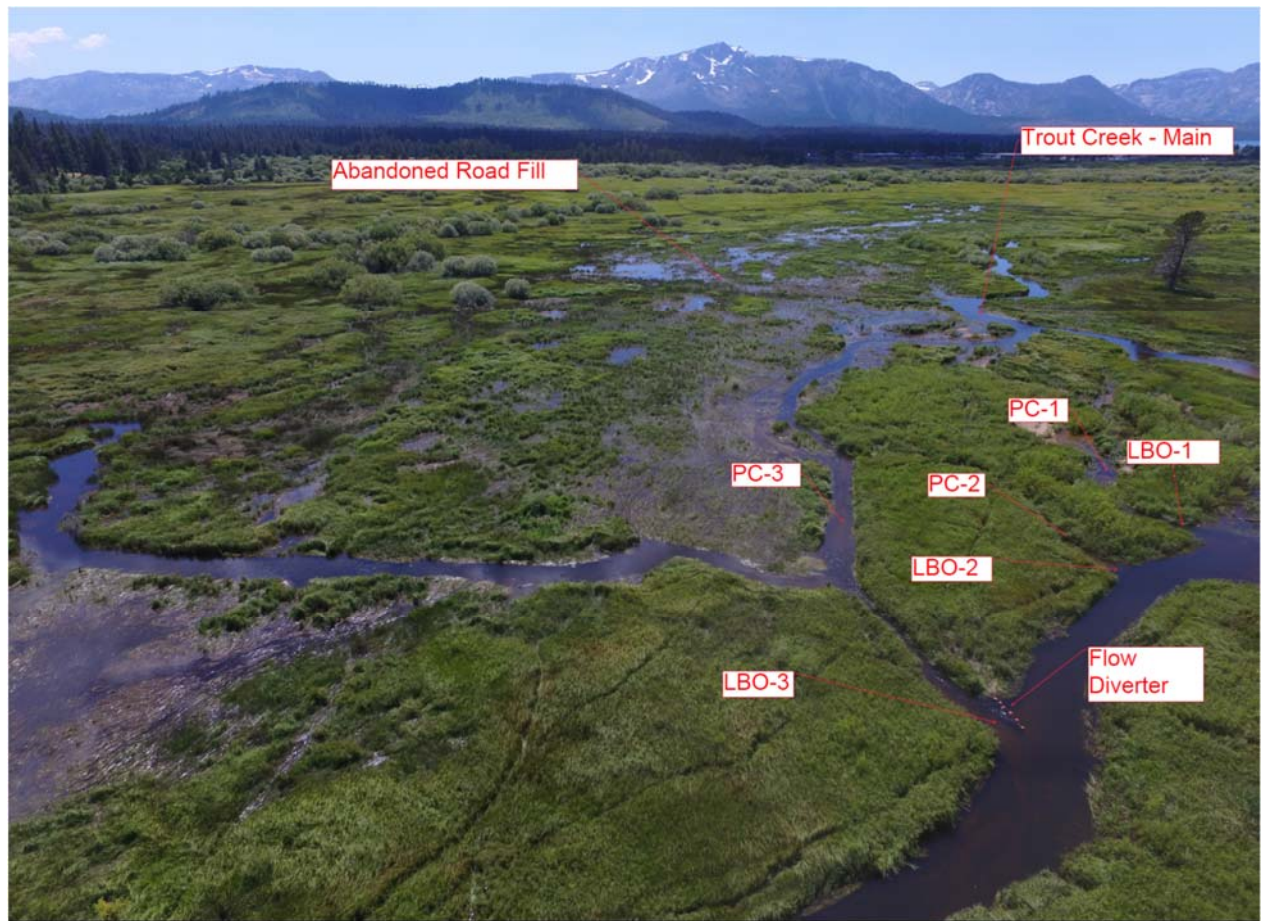
Figure 4-10. Upstream of Bellevue work area looking west, 28 July 2017, with pilot channels diverting flow to left)

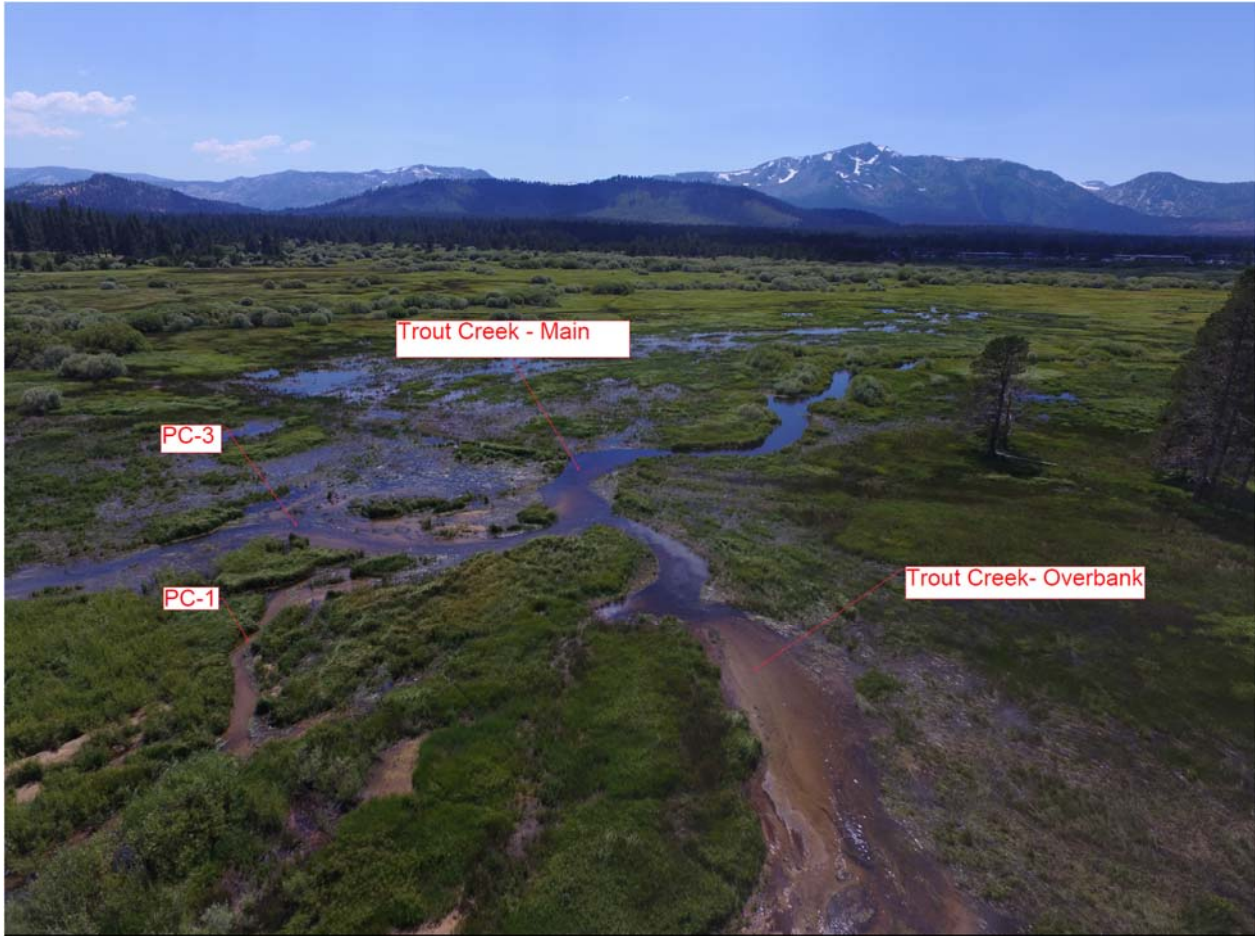
Figure 4-11. Easement and avulsed channel area looking west, 28 July 2017 (hummocks in easement along fence on right side of photo)

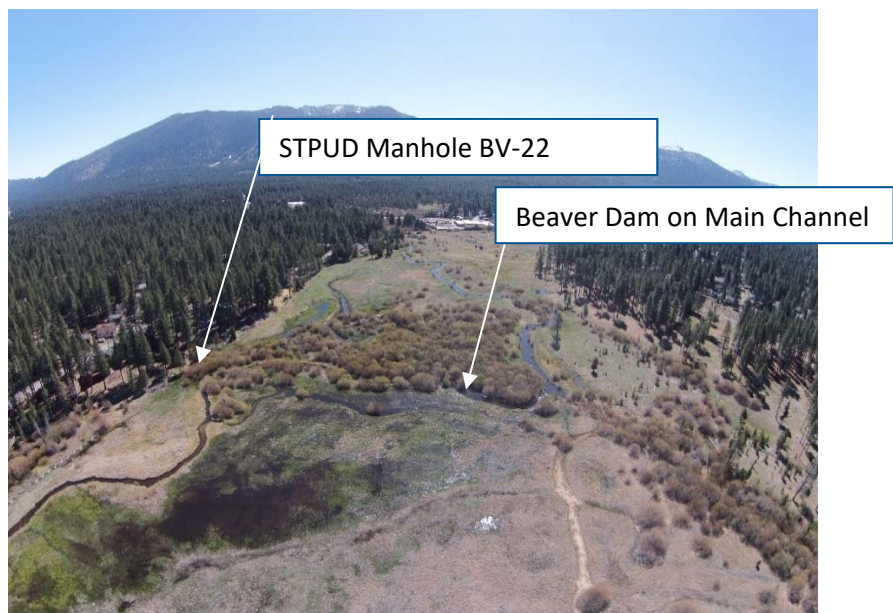
Inundation by beaver activity was a primary cause of flooding in the easement in the fall of 2016 and 2017, and effectively prevents typical maintenance access along the easement. Year 3 improvements (see Section 5 below) were designed to slightly raise ground levels and plant vegetation in areas around the manholes and other low points, but were expected to provide limited benefits against inundation by beaver activity. Maintenance activities in Year 4 (see next section) were designed to alleviate some of the flooding and temporarily restore channel capacity. However, it was recognized that continued beaver activity may again result in worsened overbank flooding, and a more comprehensive solution to inundation caused by beavers is still needed.

Figure 4-12. Inundation of meadow at low flow (approximately 25 cfs) due to beaver activity, as mapped in April 2015.

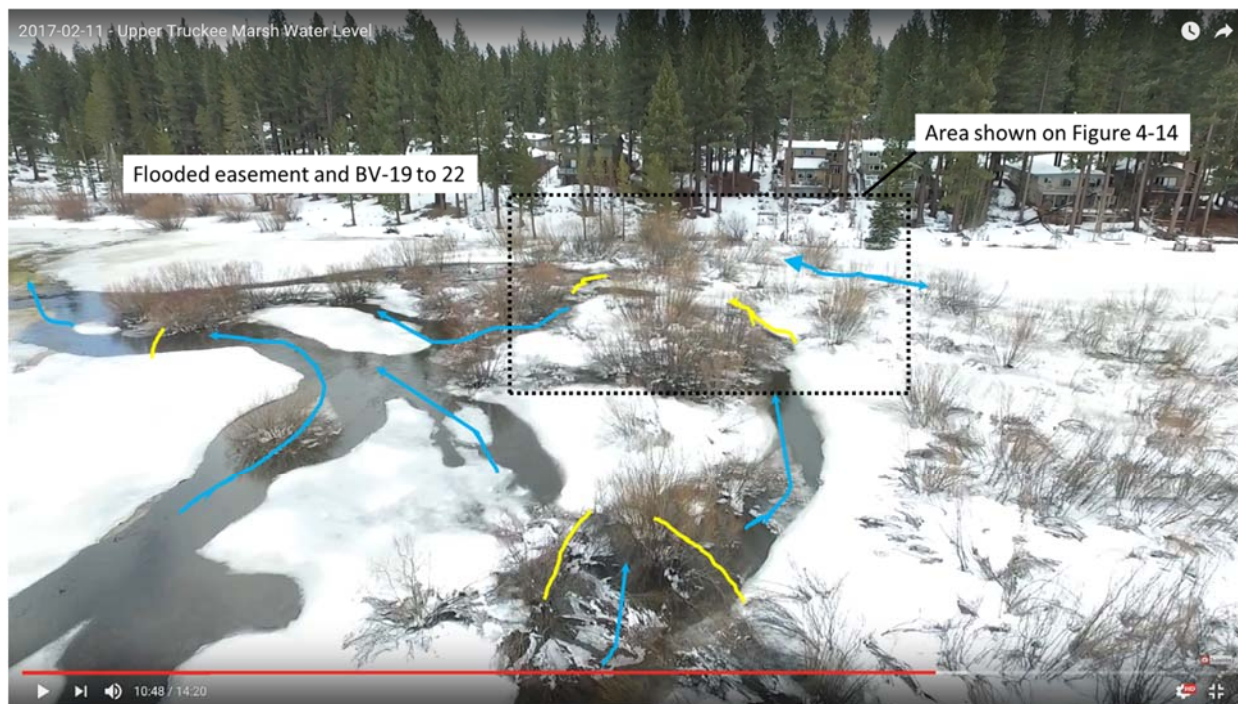
Figure 4-13. Aerial photo showing beaver dam locations and flow paths, February 2017. Yellow lines indicate dam locations and blue lines indicate flow paths

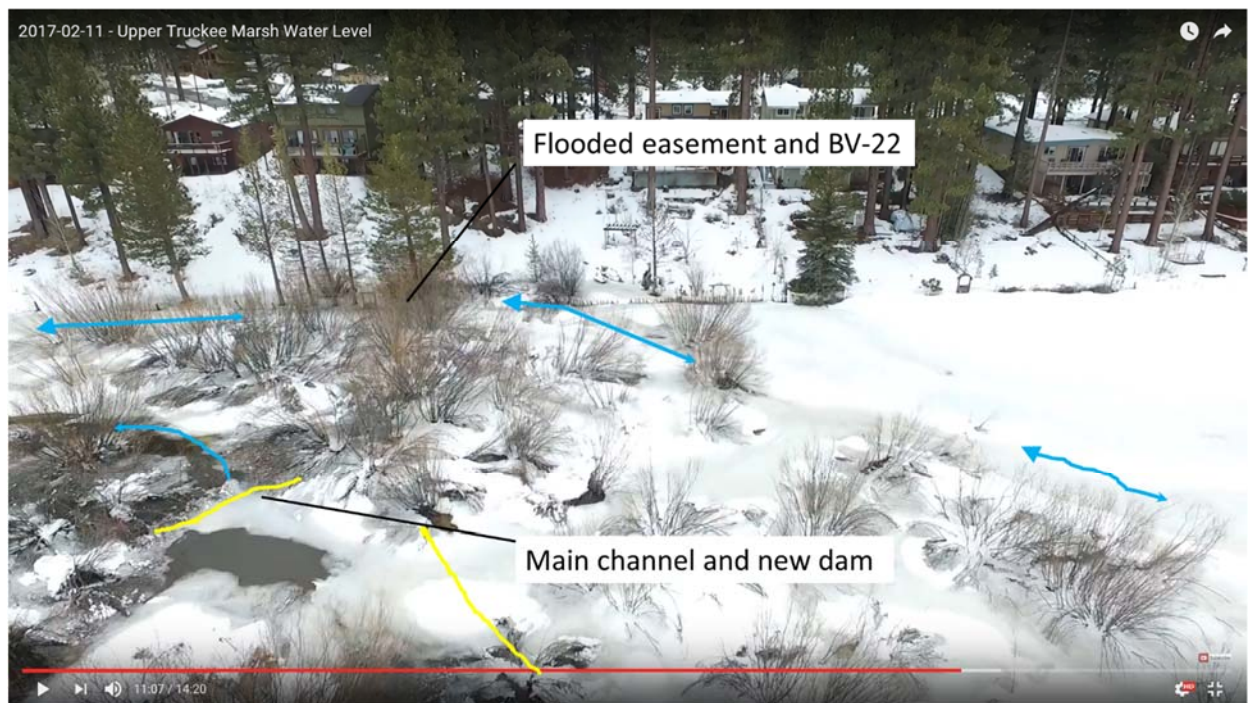
Figure 4-14. Aerial photo showing beaver dam locations and flow paths, February 2017. Yellow lines indicate dam locations and blue lines indicate flow paths

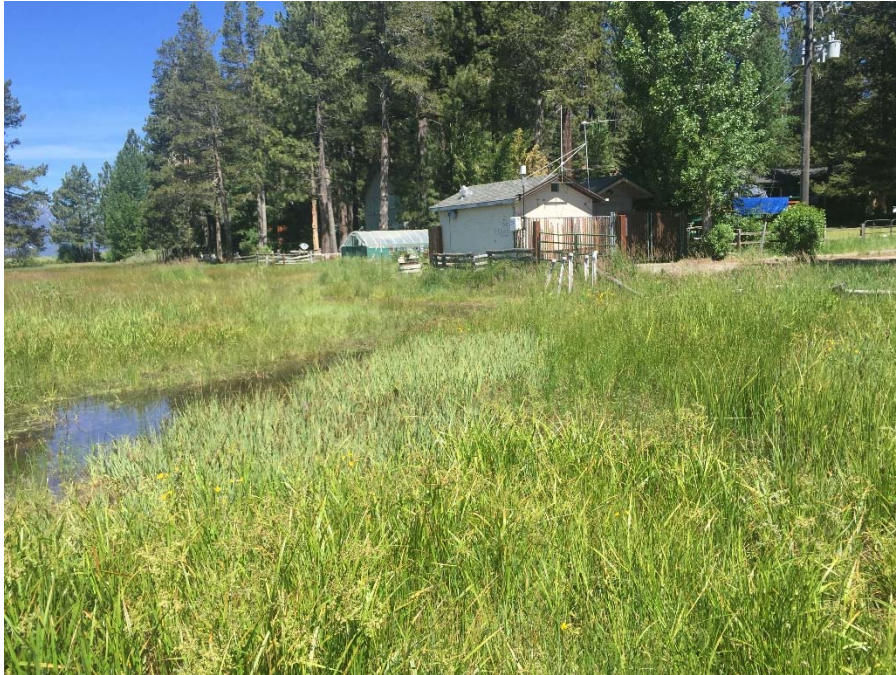
Easement Near Bellevue
Pump Station (white
stakes are at MH
BV17)

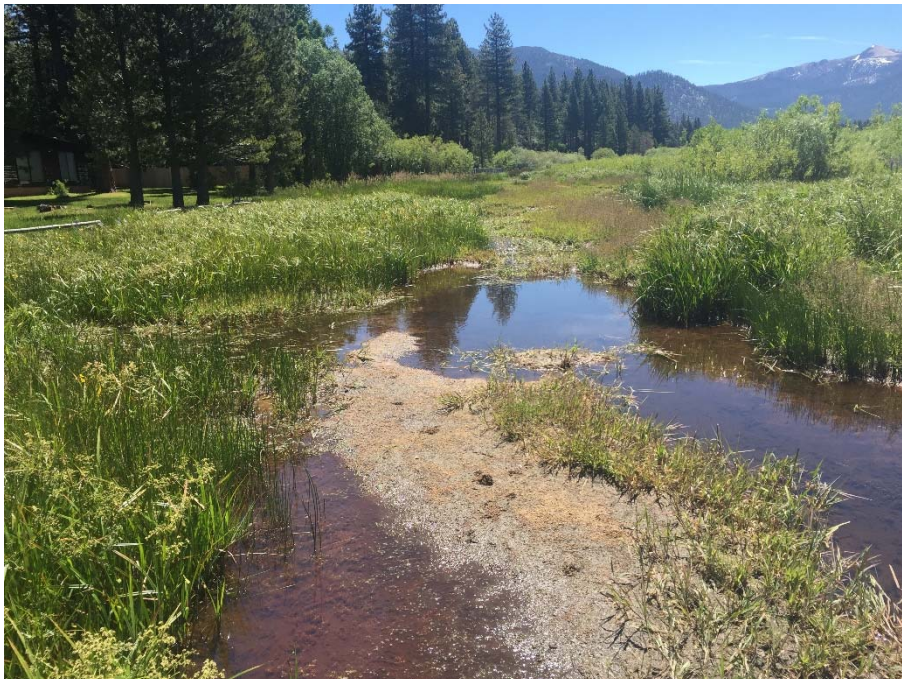
Very low flow adjacent to
easement (<1 cfs
downstream of pilot
channel inlets)

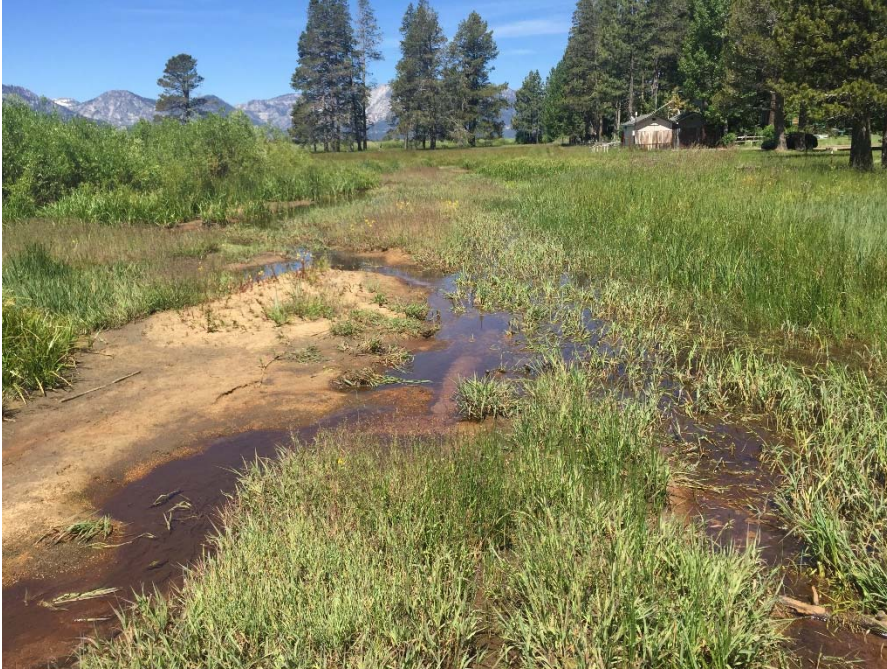
Looking downstream towards Bellevue in swale. Easement along right side of photo outside of low flow swale

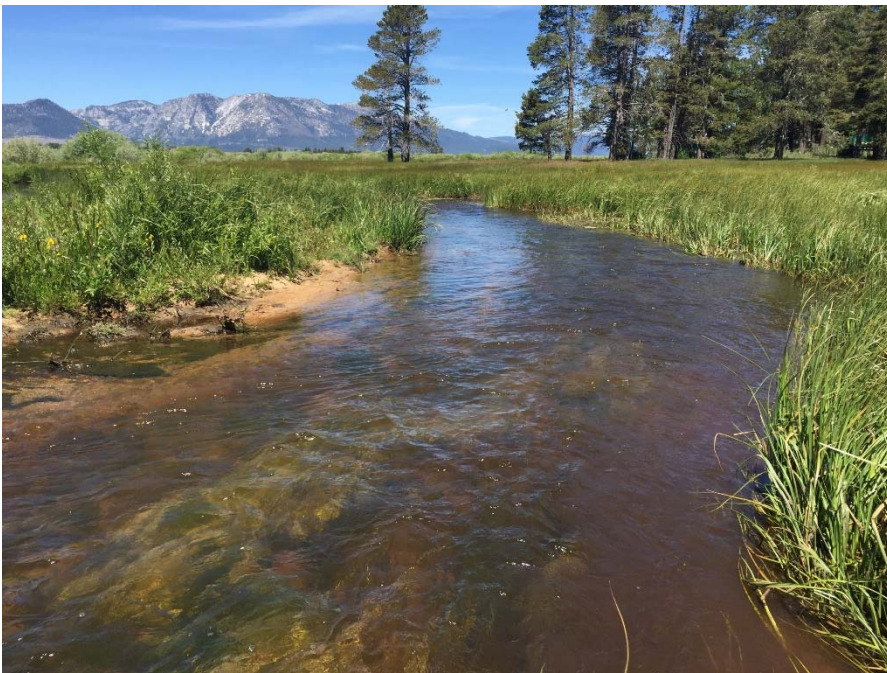
Main pilot channel flow near discharge to pre-avulsion Trout Creek channel

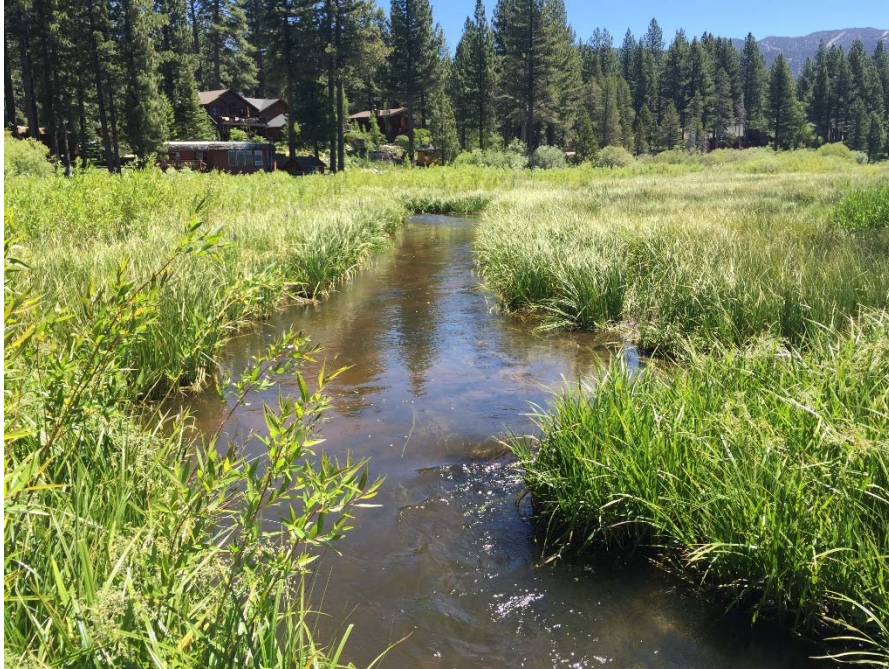
Pilot Channel 3 looking upstream towards inlet

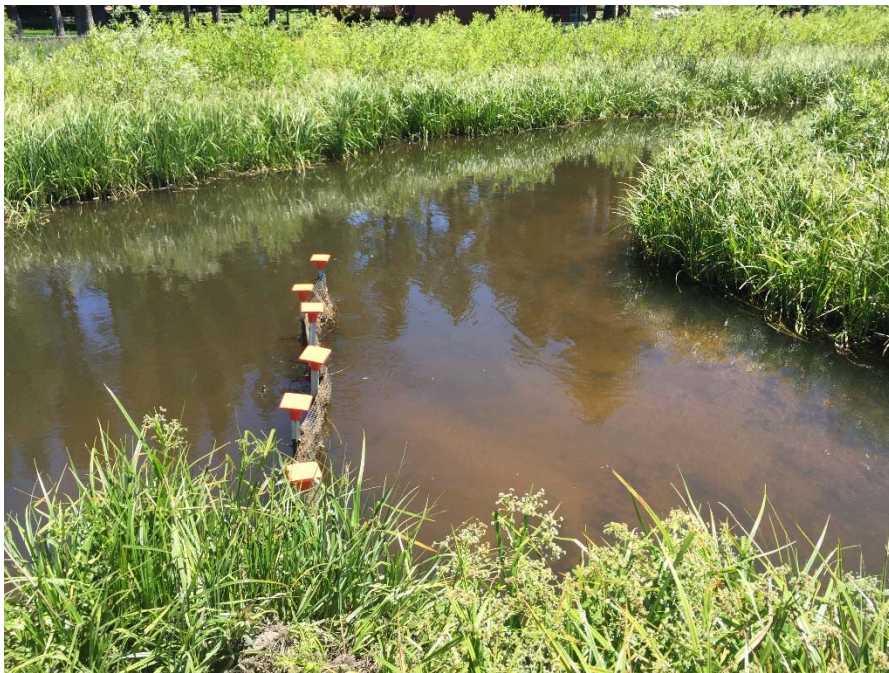
Pilot Channel 3 inlet with flow deflector

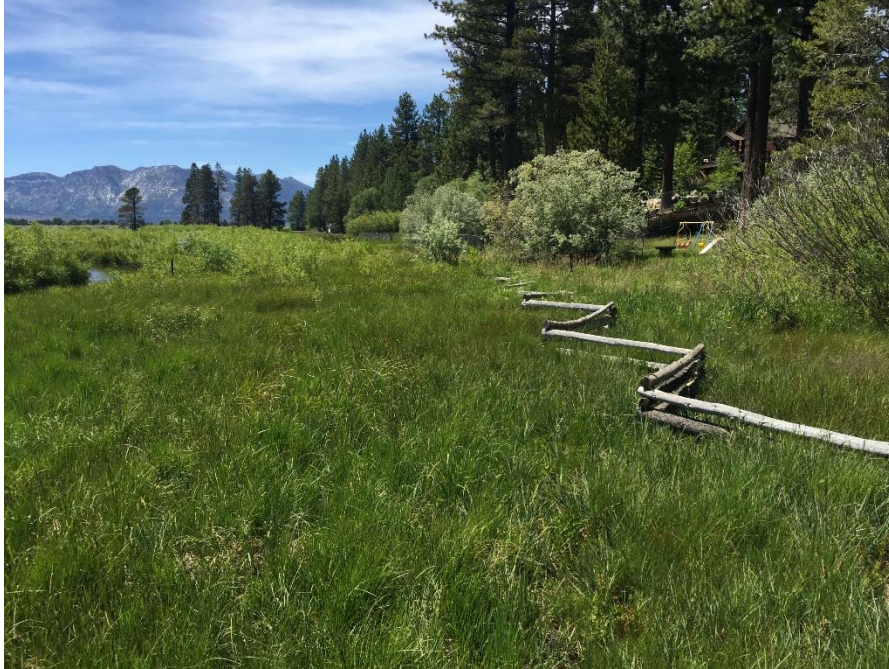
Easement between BV 20 and BV19 looking downstream; CTC parcel on right

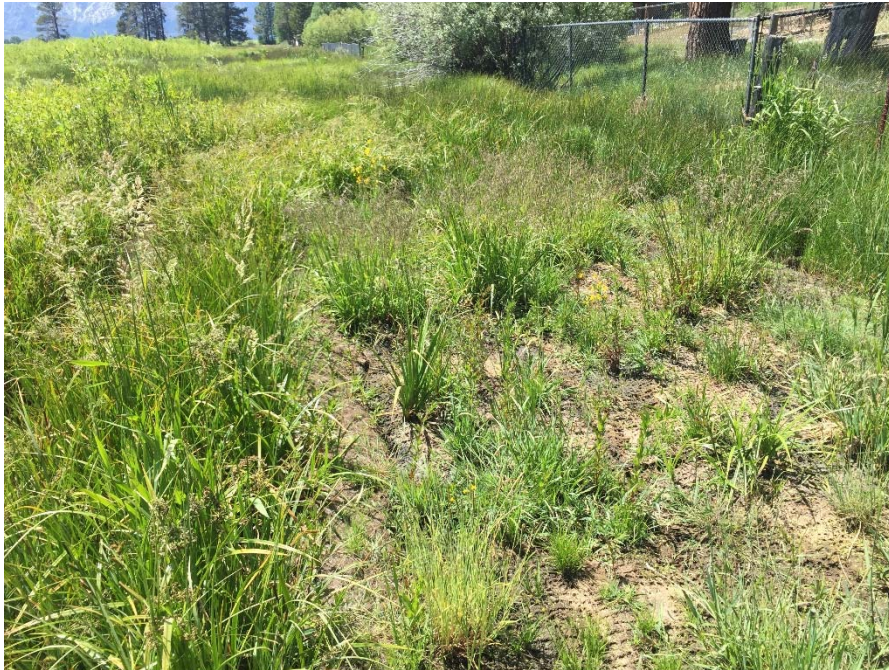
Hummock constructed in Y3 near BV 19

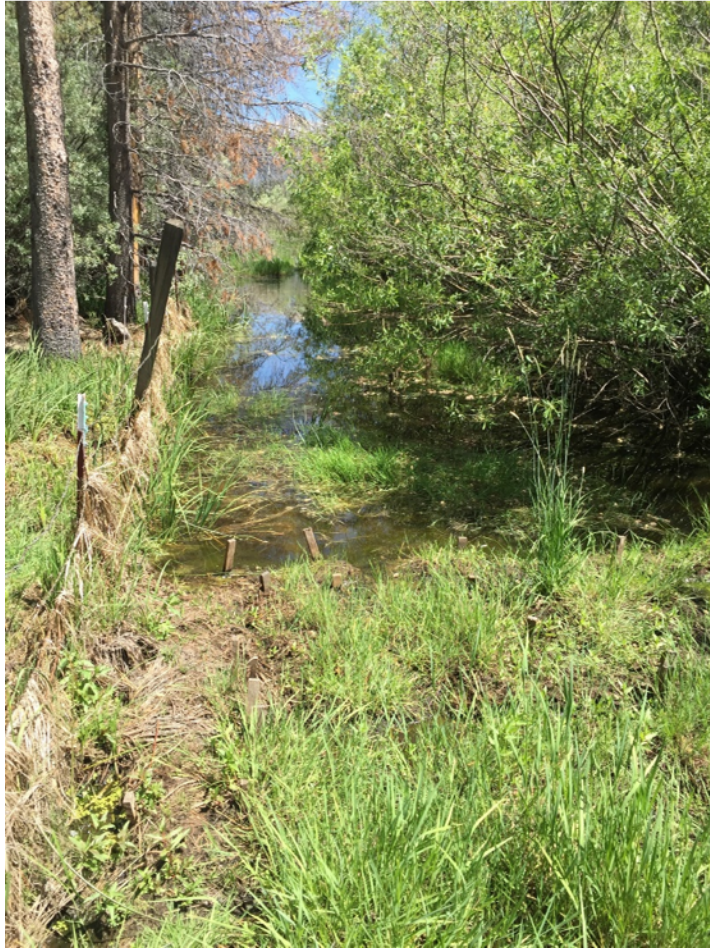
Persistent inundation due to beavers near upstream end of hummock between BV 21 and BV 22

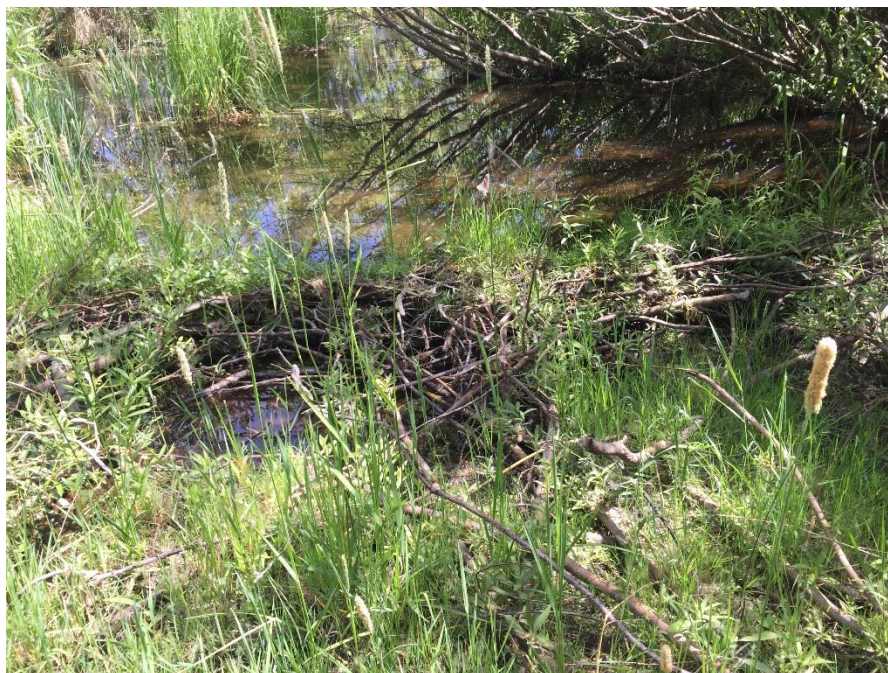
Auxiliary beaver dam blocking return flow from inundation area to creek near BV22

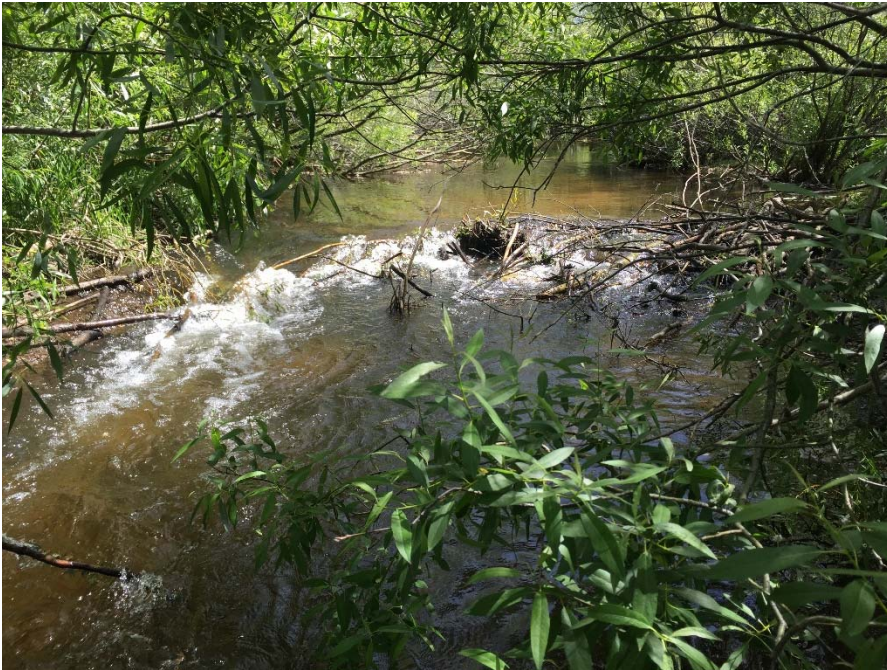
Beaver dam on main channel looking upstream

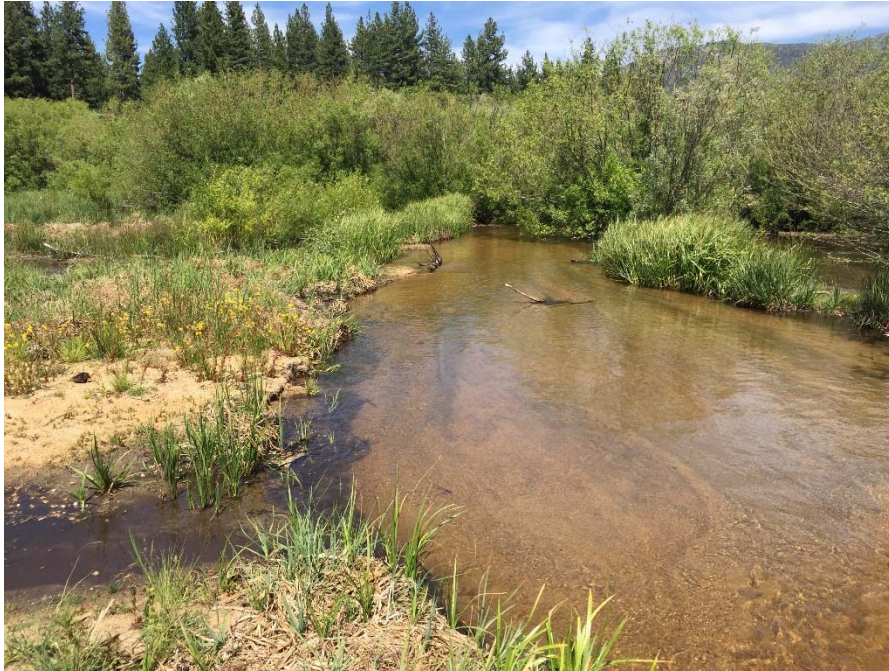
Inundation of the right overbank by beaver activity is expected to continue and may change in location or severity from time to time. Beaver activity has also caused the main Trout Creek channel to fill with sand, increasing the probability for a new avulsion. The extensive overbank flooding due to beaver activity may also contribute to generally higher groundwater levels, filling topographic depressions in and near the easement. The measures developed in the Adaptive Management Plan did not specifically target this source of inundation and a change in management appears to be needed to ensure access to the sewer line upstream of Bellevue for maintenance. One option would be to raise the entire easement

Sand nearly filling main Trout Creek channel upstream of two beaver dams

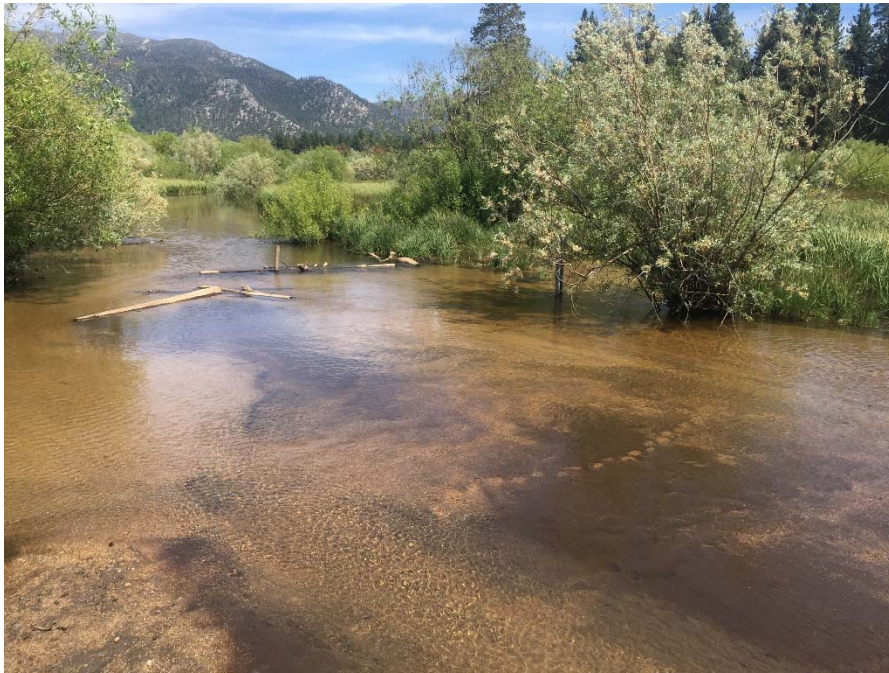
Sand in main channel upstream of bend to right near head of secondary channel
