# UPPER TRUCKEE MARSH SEWER FACILITIES ADAPTIVE MANAGEMENT PLAN

## **2016 ANNUAL REPORT**

## **South Tahoe Public Utility District**

8 February 2017

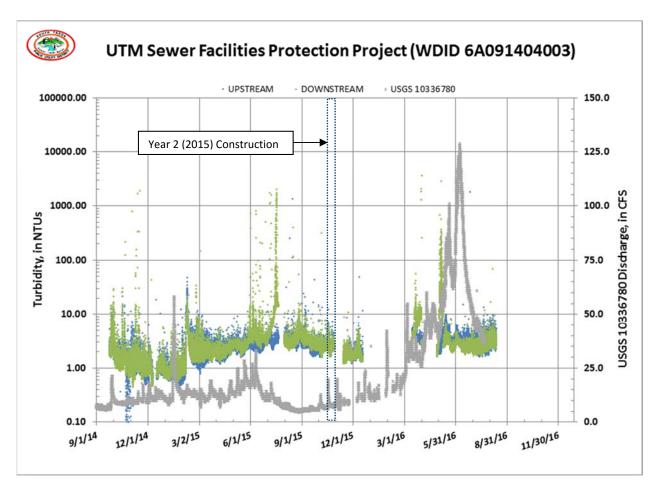
Figure 3-1 shows the data from the recording turbidimeters upstream and immediately downstream of the Bellevue work area where the pilot channels were expanded.

Figure 3-1. Turbidity upstream and downstream of Bellevue Avenue work area during Year 2 construction period, Oct 2015

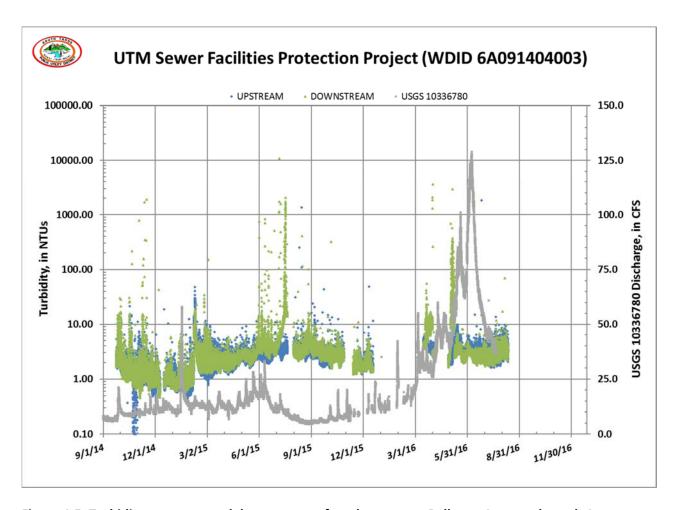
Figure 4-5 shows the turbidity measurements upstream and downstream of the work area near Bellevue Avenue for the period during and after Year 2 construction through August 2016. Trout Creek flows at USGS 10336780 are also shown in the plot. Although there are outlying data points indicating short duration elevated turbidity levels both upstream and downstream of the work area, the data generally show turbidity levels to be similar at the two stations and to generally be less than about 8 NTUs, and

show that increases in discharge do not result in elevated levels of turbidity at the downstream station, thus indicating that the project area has not been a significant source of fine sediment during high flows.

Figure 4-5. Turbidity upstream and downstream of work area near Bellevue Avenue through August 2016

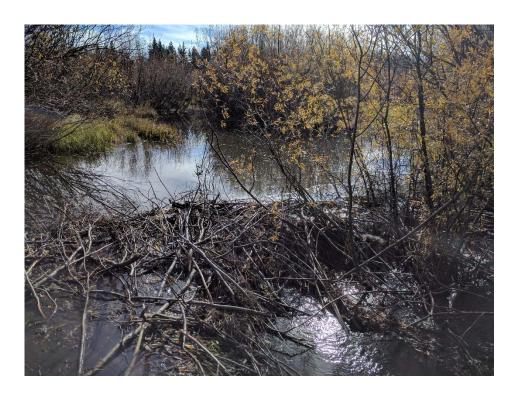
Beaver activity upstream of the Bellevue work area increased in 2016, resulting in long duration overbank flooding of the District's easement and several of the manholes on the gravity sewer. The inundation area created by beaver activity is shown in Figure 4-9. The increase in flooding in 2016 appears to be related to construction of an extensive system of auxiliary beaver dams on flow paths that return overbank flows to the main channel. The blockage of these return flows causes overbank flows near the District's Manhole 22 to continue down the right overbank. Several areas of ponded water were evident in this area in August 2016, including areas near Manholes 18, 19, 21, and 22. Beaver activity also closed the head of the secondary channel where the District had constructed a pilot channel in Year 2.

Inundation by beaver activity was the primary cause of flooding in the easement in 2016, and effectively prevents typical maintenance access along the easement. Year 3 improvements (see Section 5 below) were designed to slightly raise ground levels and plant vegetation in areas around the manholes and other low points, but are expected to provide limited benefits against inundation by beaver activity. A more comprehensive solution to inundation caused by beavers should be explored in Year 4.

Figure 4-10. Beaver dam on return flows near STPUD Manhole BV22, Oct 2016

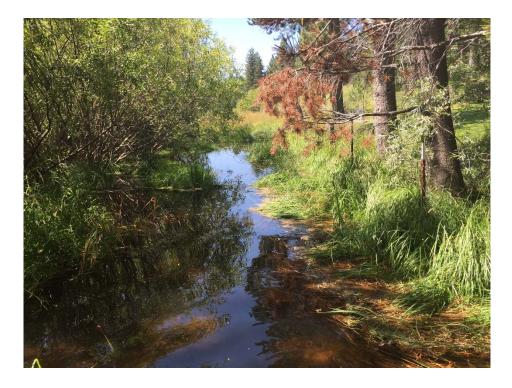
Figure 4-11. Inundation in District easement downstream of Manhole BV22, Aug 2016

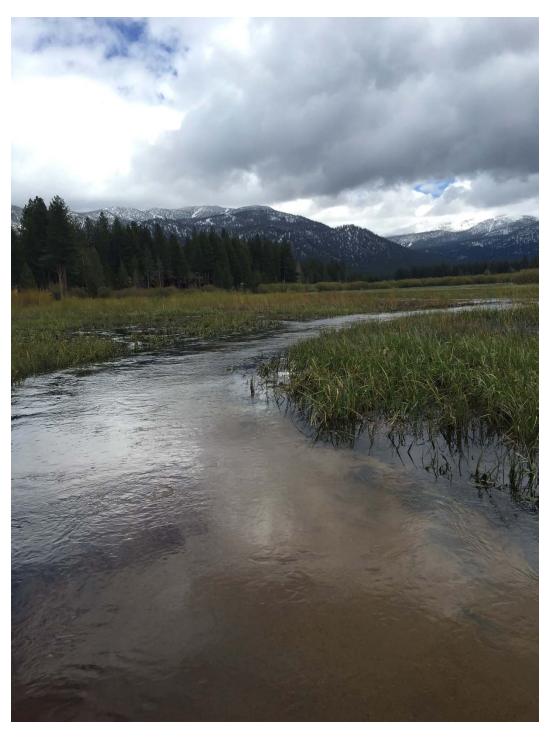
Photo 1. Return flow from pilot channels to Trout Creek. PC1 is entering from left side of photo. Overbank flooding on both sides of pilot channel, but velocities are near zero. Pilot channel return is dominant flow. Trout Creek was also flowing overbank downstream of site.

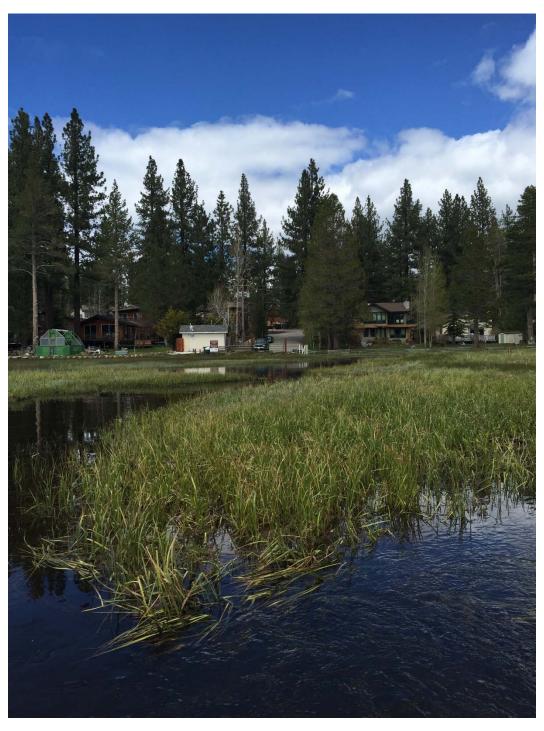
Photo 2. Near pilot channel return (in foreground) looking towards Bellevue PS. Overbank flow shallow, low velocity. PC return flow velocity about 2 fps (foreground).

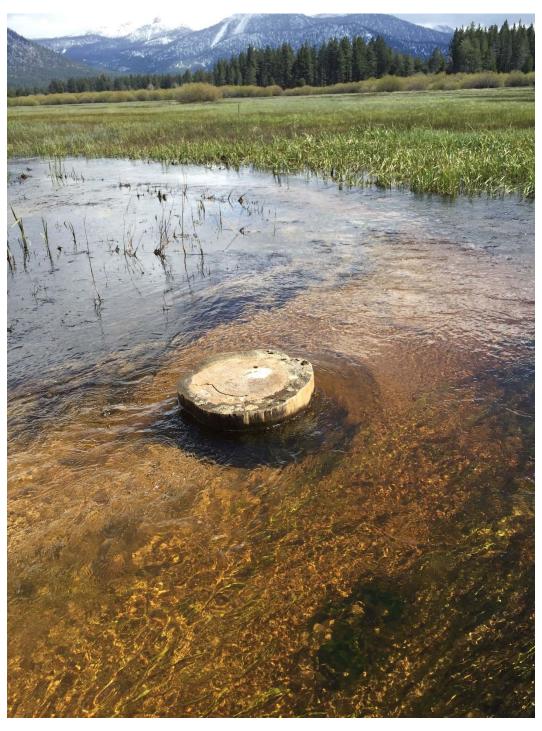
Photo 3. Pilot channel combined flow at bend upstream of PC 1 outlet. Scour evident around stump that was transported in and deposited by pilot channel flows.

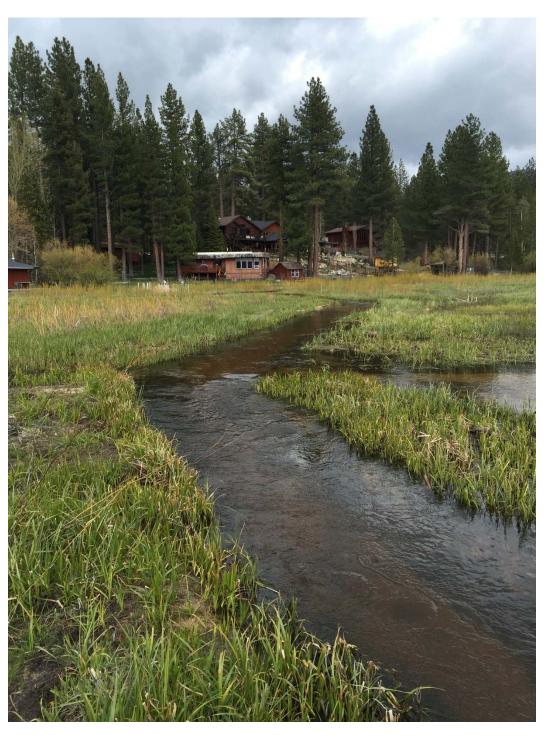
Photo 4. Pilot Channel 3 flow, about midway between head and outlet. Right overbank (left side of photo) revegetating after use for construction access and spreading of excavated material in 2015.

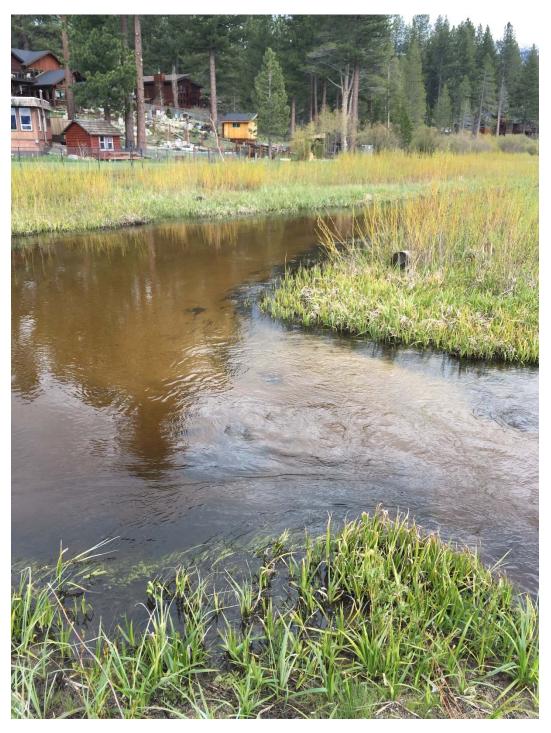
Photo 5. Head of Pilot Channel 3, looking upstream on Trout Creek; velocities at channel entrance higher than Trout Creek.

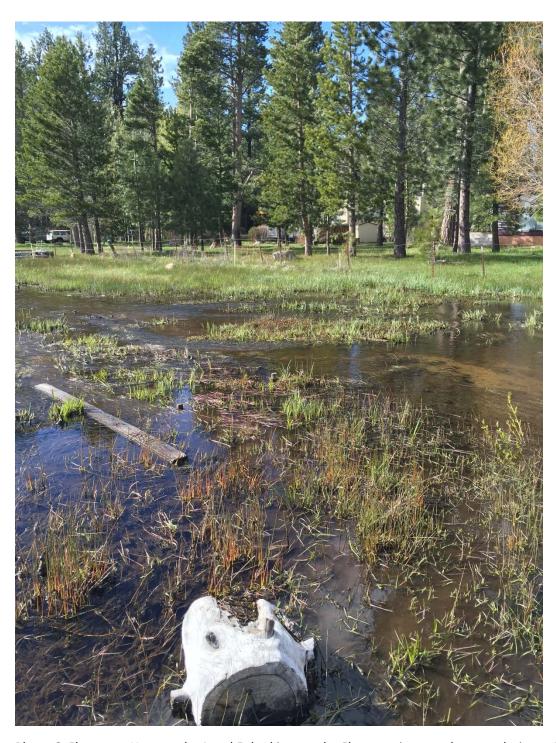
Photo 6. Flow over Hummocks 4 and 5, looking north. Flow passing over hummocks is carried in right overbank downstream, but little flow occurs along fence in easement area.

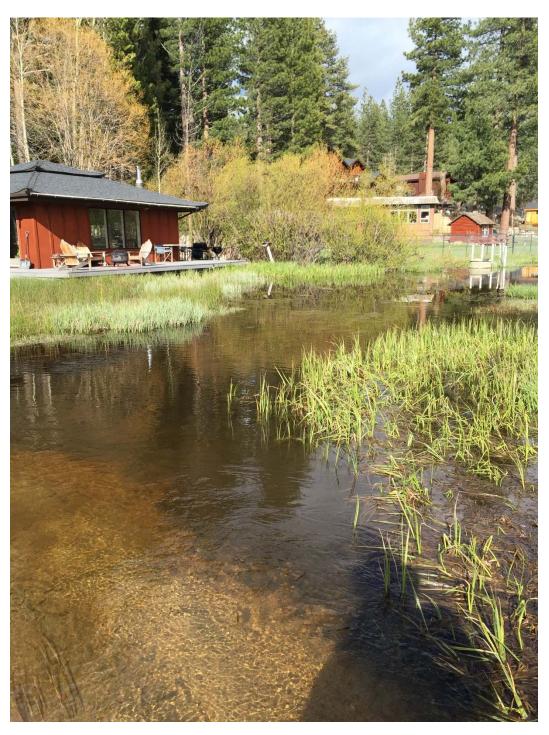
Photo 7. Looking upstream from Hummock 4 and 5 in right overbank. Flooding occurs upstream of avulsion area for several hundred feet at this flow (42 cfs at USGS 10336780).

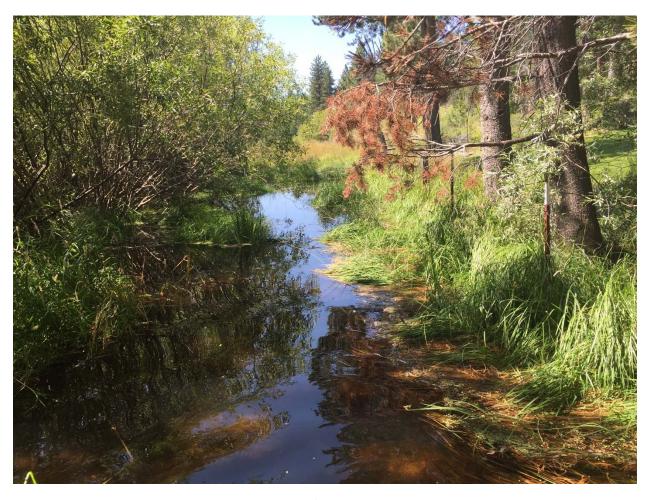
Photo 8. Flooding in right overbank downstream of BV22 due to beaver dam inundation

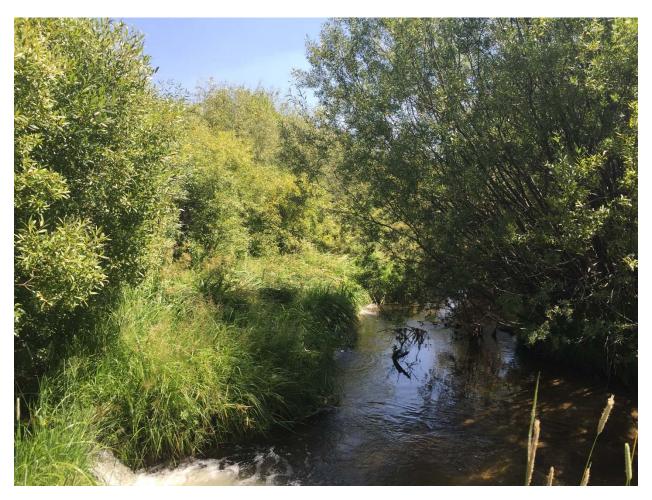
Photo 9. Flows spilling back into Trout Creek at two beaver dams on return flow channels along right bank of Trout Creek near BV22. Main beaver dam is about 150 feet upstream.

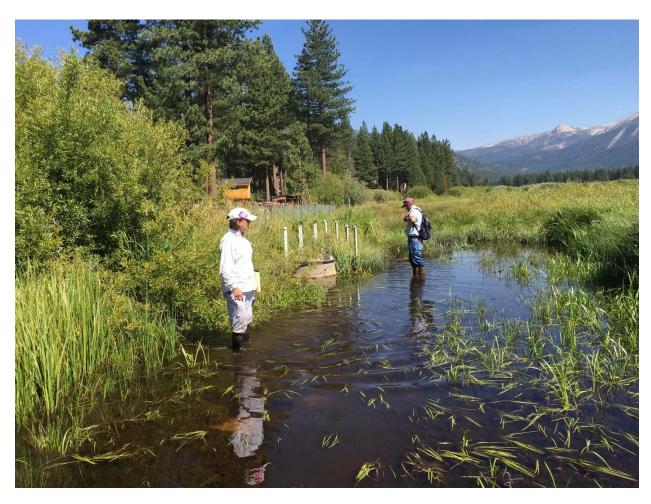
Photo 10. Inundation on right overbank at BV 18.

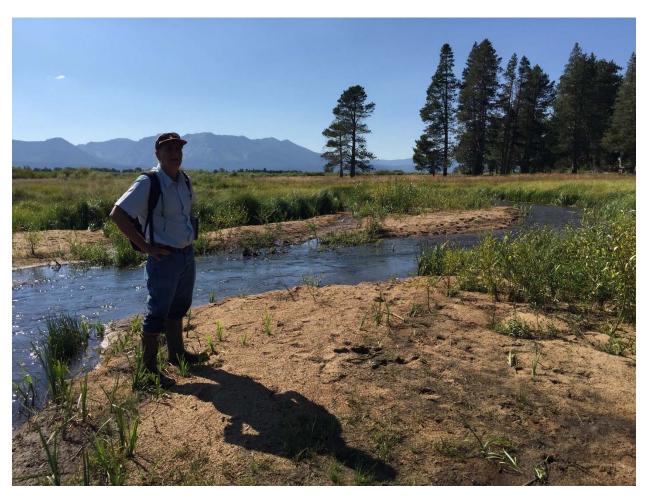
Photo 11. Deposition from overbank flow on pilot channels, approximately 100 feet upstream of outlet. Pilot channel flow at about 2 fps.

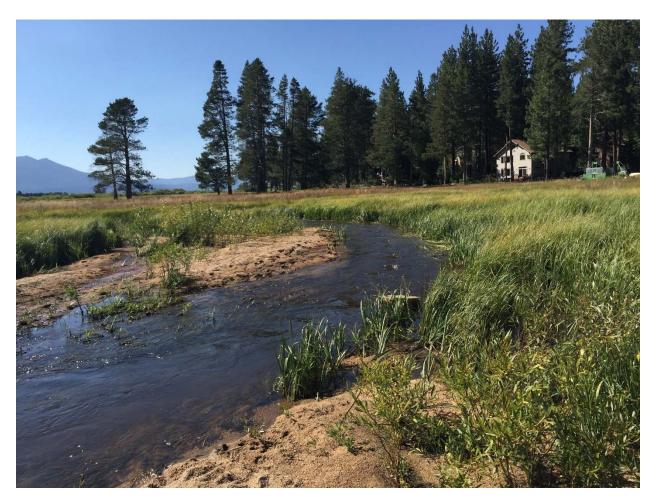
Pilot channel flow near outlet, looking downstream.
