# South Upper Truckee Well Update

Mark Seelos  
Water Resources Manager  
12/21/2023

# South Upper Truckee Well No. 3

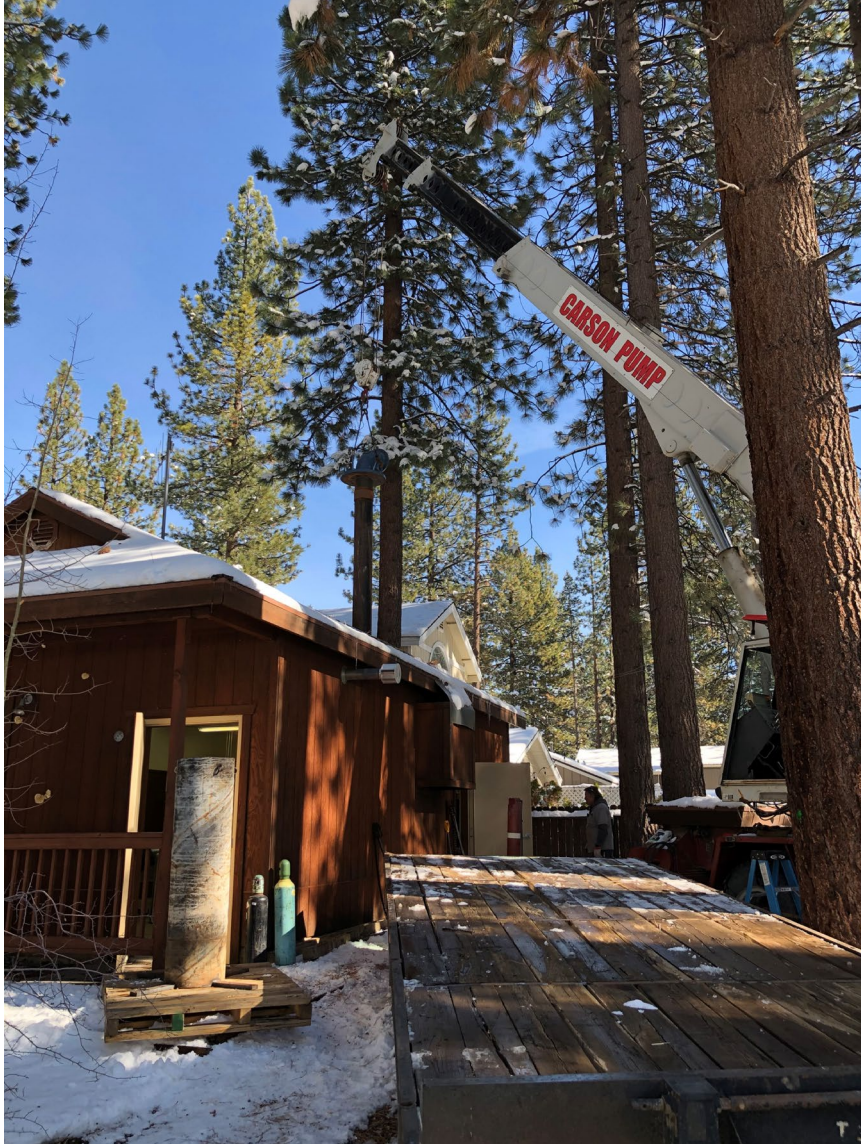
## December 12 Inspection

- Carson Pump
- Pulled Pump and Column
- Inspected Column Pipe and Pump
- Meggered motor at wire, pigtail, and leads.
