UPPER TRUCKEE MARSH SEWER FACILITIES ADAPTIVE MANAGEMENT PLAN

2017 ANNUAL REPORT

South Tahoe Public Utility District

Northwest Hydraulic Consultants Inc.

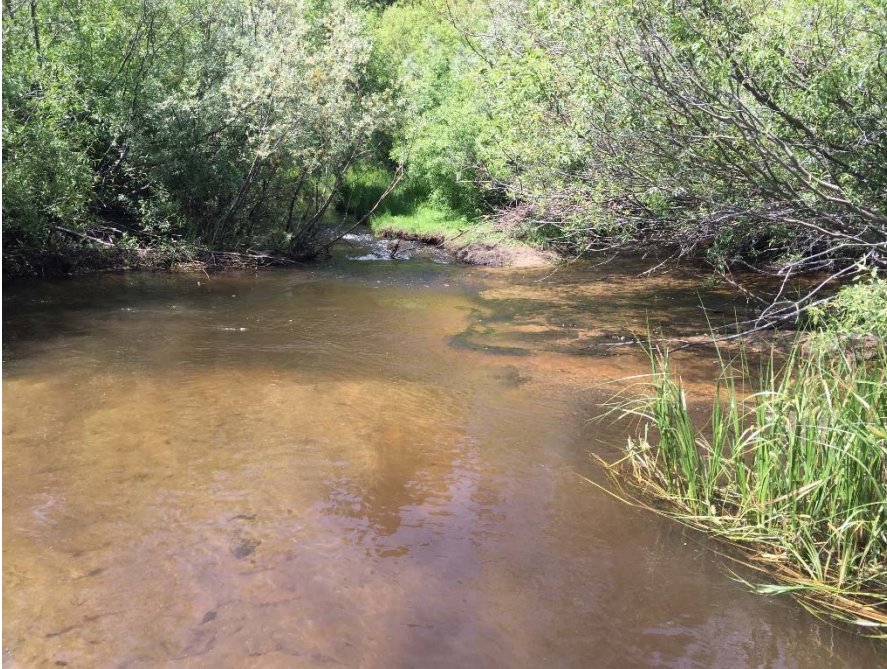
Beaver dam on main channel showing accumulation of sand behind dam, looking downstream
