# UPPER TRUCKEE MARSH SEWER FACILITIES ADAPTIVE MANAGEMENT PLAN

## **2016 ANNUAL REPORT**

## **South Tahoe Public Utility District**

8 February 2017

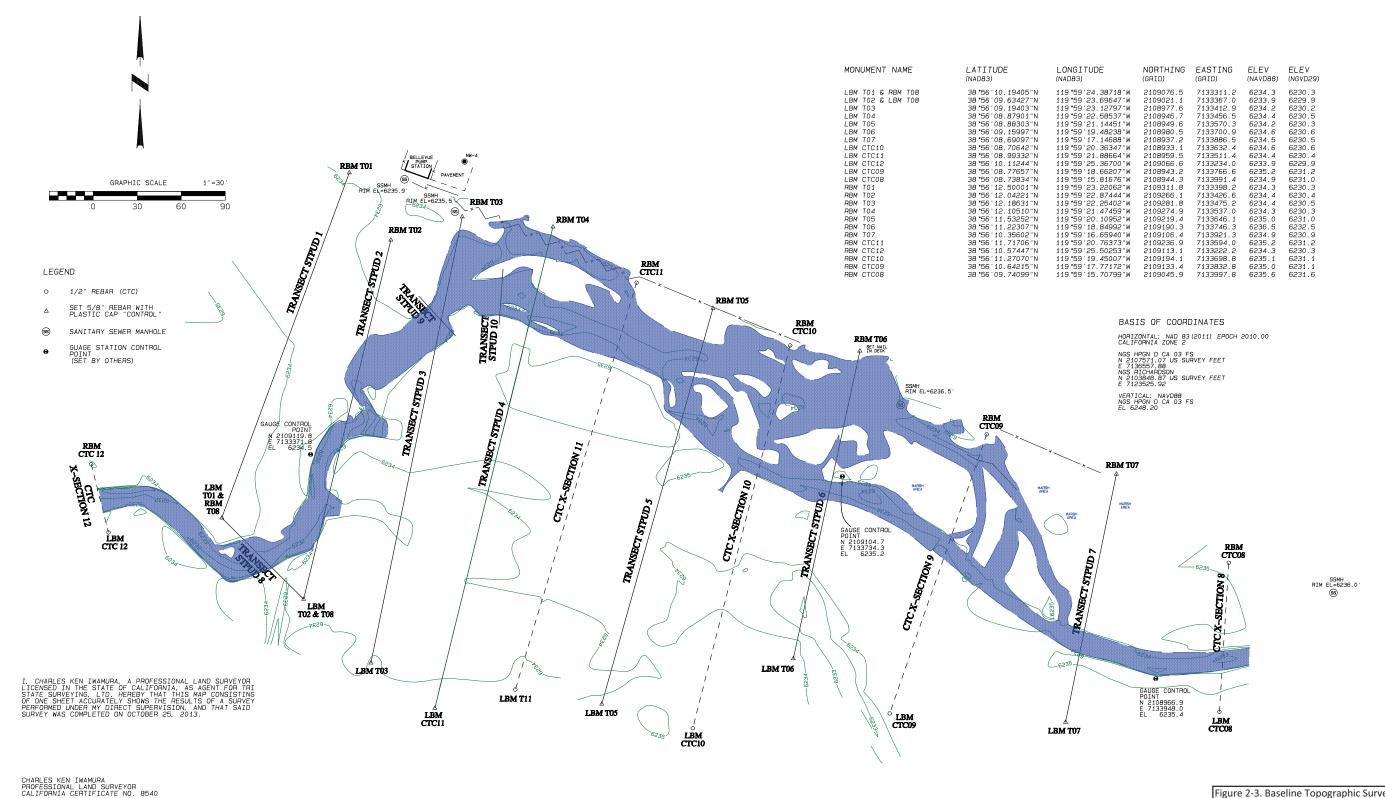
Inundation of the sewer easement near Bellevue Avenue was mapped in October 2013 as part of the field survey and observed prior to Year 1 construction operations in the spring and summer of 2013 and 2014. Figure 2-3 shows the area inundated on the baseline survey date, which had a recorded flow of 11 cfs at the USGS Gage 10336780 Trout Creek at Tahoe Valley. In the baseline condition, a section of the main channel was entirely blocked as a result of the 2011 channel avulsion, and most all of the creek flow was passing over the right overbank and sewer easement. Thus, regardless of flows in the creek or season, the sewer easement was continuously inundated in the area near Bellevue Pump Station. Figure 2-4 shows a photo of inundation in the easement near Bellevue Avenue in May 2013 at a flow of approximately 40 cfs. Figure 2-5 shows a photo of inundation during April 2014 at a flow of approximately 20 cfs.

Figure 2-3. Baseline Topographic Survey near Bellevue Avenue (source: Tri-State Surveying; full survey in Appendix A)

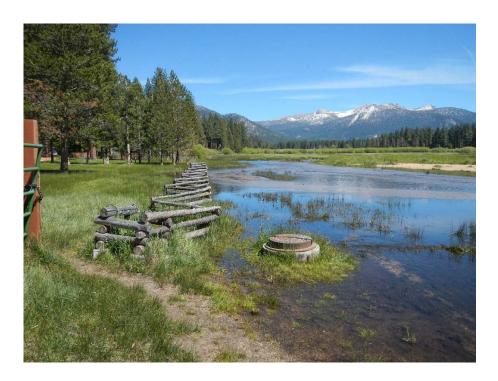
Figure 2-4. Inundation of the sewer easement near Bellevue Avenue at a flow of approximately 40 cfs, looking upstream, 20 May 2013

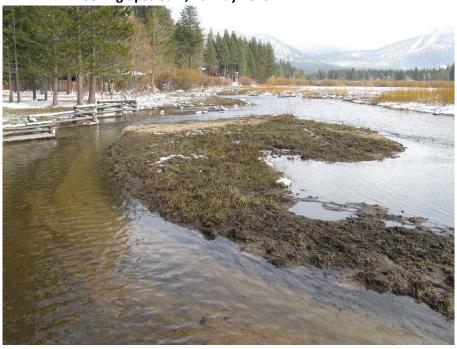
Figure 2-5. Inundation of the sewer easement near Bellevue Avenue at a flow of approximately 20 cfs, looking upstream, 1 Apr 2014

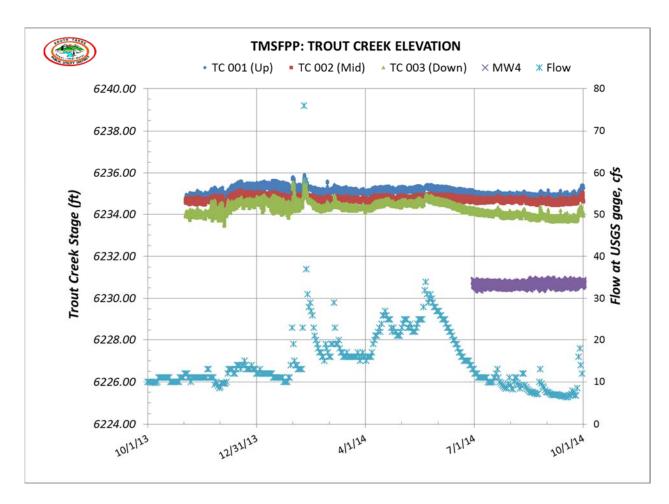
NHC and the District installed three pressure transducers in the project area near Bellevue Avenue along the Trout Creek channel in November 2013. The pressure transducers record data on a set 30-minute time interval for later download. Figure 2-6 shows the location of the stream water level sensors and Figure 2-7 shows the water level data plotted against flows at the USGS gage. The baseline water level conditions reflect discontinuous channel conditions – the Trout Creek channel between the middle and downstream gages was completely filled with sediment and the entire flow was occurring on the right overbank. In addition to the transducers along the stream channel, the District installed a transducer in an existing monitoring well (MW4) near the end of Bellevue Avenue in July 2014. Groundwater levels prior to September 2014 (beginning of Year 1 construction) are shown in Figure 2-7.

Figure 2-7. Water levels and flows at USGS Gage 10336780 in prior to Year 1 activities

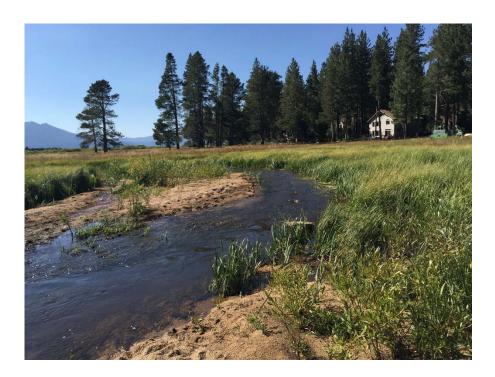
In addition to higher flow capacity, active bed load transport and bed form development (scour, ripples, dunes) were evident for bed load material comprised of sand and small gravel. The main pilot channel beds are now observed to have little vegetative growth and are characterized by sand in gradual transport along the bed. The peak flow during WY 2016 at USGS Gage 10336780 was approximately 130 cfs. Deposition of sand in overbanks along the pilot channel system and on the hummocks was evident site observations conducted in August 2016. Figures 4-2 and 4-3 show pilot channel conditions in April 2016.

Figure 4-2. Pilot channel flow looking downstream approximately 100 feet upstream of confluence with Trout Creek showing overbank deposition of sand during high flows, 9 Aug 2016

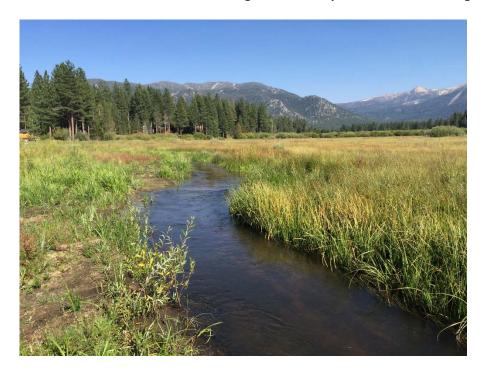
Figure 4-3. Pilot channel (PC-3) about 150 feet upstream of Trout Creek confluence, looking upstream

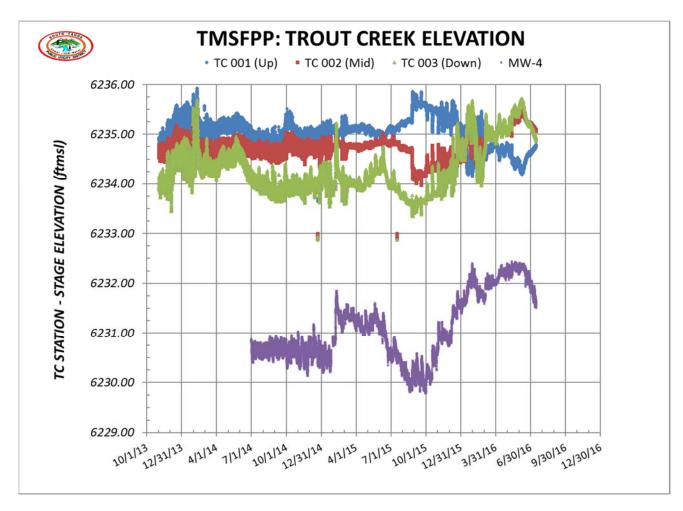
The pressure transducers shown in Figure 2-6 continued to operate following Year 2 construction. Figure 4-4 shows the water level record between October 2014 and July 2016. The water levels are intended to supplement observations on easement inundation and pilot channel performance in conjunction with survey data. Groundwater levels remained relatively constant with a slight increase during the spring that may correlate to precipitation. In the data collected to date, groundwater levels are only loosely correlated to stream stage and are below the stream levels, indicating potential for loss of flow from the stream to groundwater in the local area. The data was downloaded from the loggers on 8 December 2015 and 15 July 2016. Communication difficulty between the datalogger and the computer was noted in the last download, and data from TC 001 after December 2015 appear to be somewhat suspect. The operation of this datalogger will be evaluated in the next download. For reference, flows on Trout Creek varied from about 7 cfs on 1 October to about 130 cfs on 5 June during the WY 2016. Stages recorded at TC 003 varied about 2 feet over this flow range, and about 1.5 feet at TC 002.

Figure 4-4. Water levels through July 2016

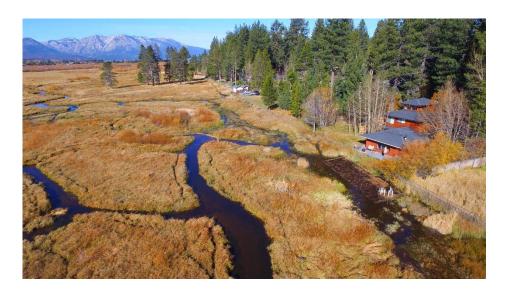
Figure 4-7. Upstream of Bellevue work area looking west, 14 Nov Apr 2016, with pilot channels diverting flow to left)

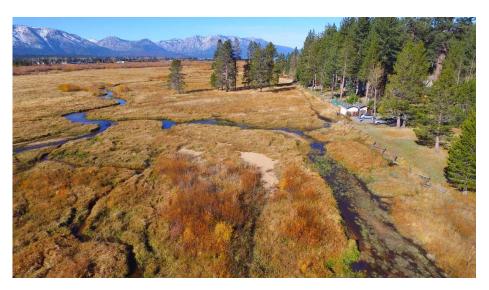
Figure 4-8. Easement and avulsed channel area looking west, 14 Nov 2016 (hummocks in easement along fence on right side of photo)

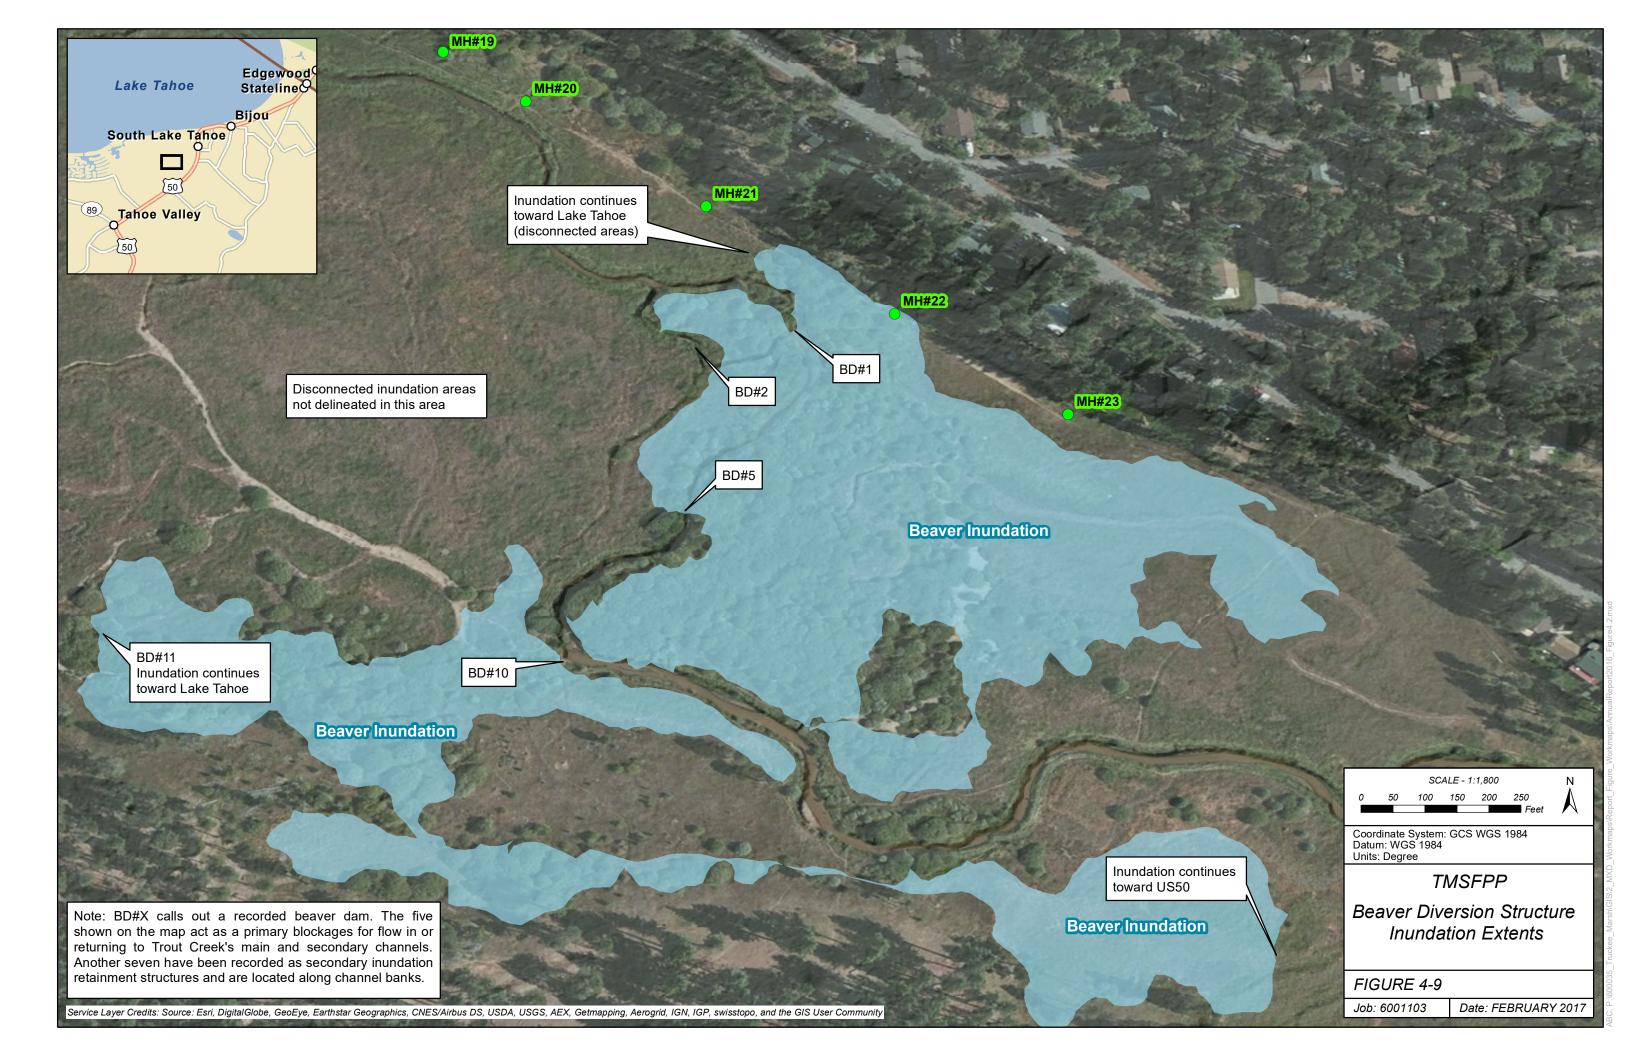
Beaver activity upstream of the Bellevue work area increased in 2016, resulting in long duration overbank flooding of the District's easement and several of the manholes on the gravity sewer. The inundation area created by beaver activity is shown in Figure 4-9. The increase in flooding in 2016 appears to be related to construction of an extensive system of auxiliary beaver dams on flow paths that return overbank flows to the main channel. The blockage of these return flows causes overbank flows near the District's Manhole 22 to continue down the right overbank. Several areas of ponded water were evident in this area in August 2016, including areas near Manholes 18, 19, 21, and 22. Beaver activity also closed the head of the secondary channel where the District had constructed a pilot channel in Year 2.

Inundation by beaver activity was the primary cause of flooding in the easement in 2016, and effectively prevents typical maintenance access along the easement. Year 3 improvements (see Section 5 below) were designed to slightly raise ground levels and plant vegetation in areas around the manholes and other low points, but are expected to provide limited benefits against inundation by beaver activity. A more comprehensive solution to inundation caused by beavers should be explored in Year 4.
