Upper Truckee Marsh Sewer Facilities Protection Project Adaptive Management Plan Closeout Report

February 9, 2022 Final Report

South Tahoe Public Utility District 1275 Meadow Crest Drive South Lake Tahoe, CA 96150 Final Report February 2022

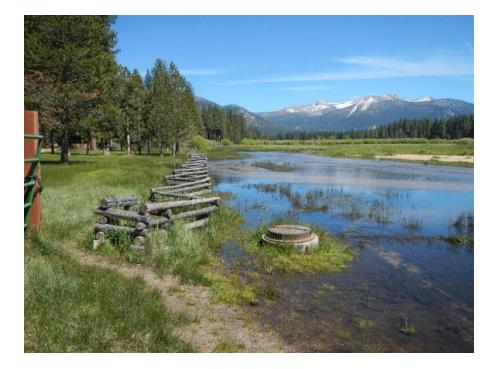
Figure 2-4. Inundation of the sewer easement near Bellevue Avenue at a flow of approximately 40 cfs, looking upstream, 20 May 2013.

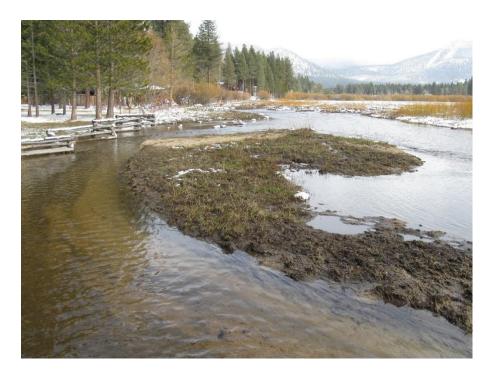
The baseline vegetation surveys focused on herbaceous vegetation in relatively undisturbed areas of the road fill and easement to establish a reference for post-construction revegetation. The area of channel avulsion was initially relatively bare (see Figure 2-5), with some willow regeneration in sandy areas of slightly higher ground between the previous channel location and the avulsed channel location.

Figure 2-5. Inundation of the sewer easement near Bellevue Avenue at a flow of approximately 20 cfs, looking upstream, 1 April 2014

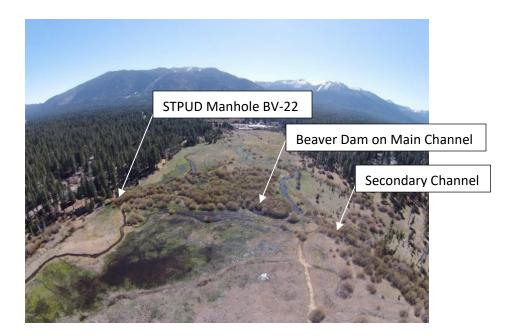
Figure 4-9. Inundation of meadow at low flow (approximately 25 cfs) due to beaver activity, as mapped in April 2015.

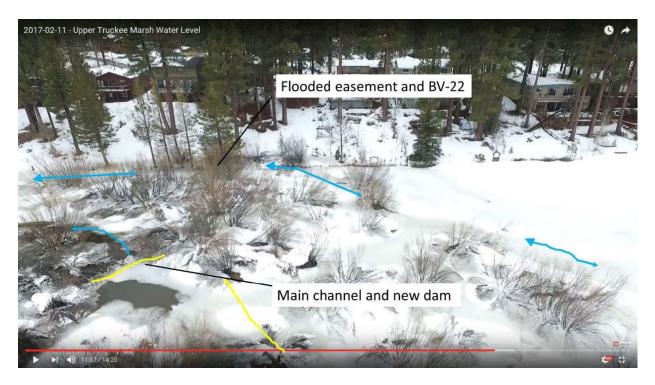
Figure 4-10. Aerial photo showing beaver dam locations and flow paths, February 2017. Yellow lines indicate dam locations and blue lines indicate flow paths.

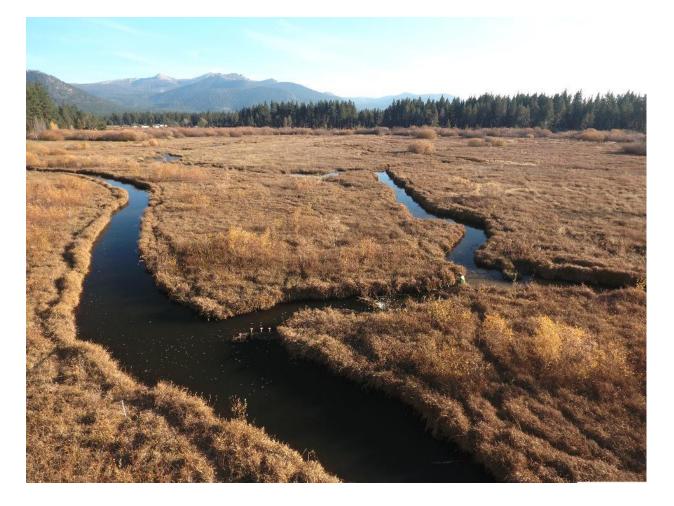
Field observations have indicated that beaver activity continued into fall 2020 (see Figure 4-12). Mapping of beaver dams and flow paths indicate that flows on the easement are due to overbank flows that originate around BV-22 (Figure 4-13). In addition, reconnaissance of the secondary channel in the center of the marsh (historical main channel location prior to 1969) in 2020 and 2021 indicates the presence of several beaver dams across the channel and auxiliary dams along the banks. It is recognized that beaver activity will likely continue inundating the easement and a more comprehensive solution to inundation is still needed.

Figure 4-12. Upstream view of Trout Creek and PC-3 in November 2020; note the beaver dam in the middle of PC-3 and a surveyor for scale.

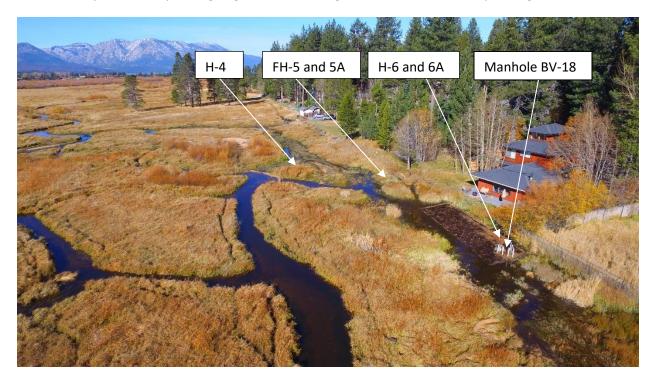
Post-construction monitoring included resurveying established cross sections and topographic mapping, continued water level and turbidity measurements, and revegetation monitoring. The surveying in October 2015 showed little change in topography (refer to Appendix C for cross section), although recent deposition was evident in some areas of the project features. Changes in channel geometry were primarily associated with constructed expansion of the pilot channels, indicating that the project area continued to be stable (as can be seen in Figure 4-14).

Figure 4-14. Upstream of Bellevue work area looking west, 14 Nov 2016 (with pilot channels diverting flow to left). District utility easement was inundated in area of BV-18 within overbank area right of the main channel of Trout Creek.

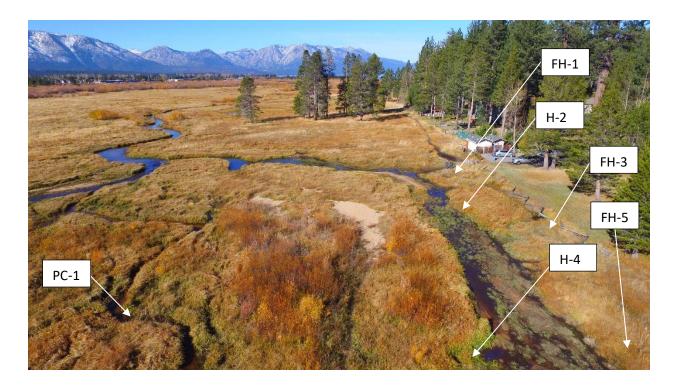
Figure 4-15. Easement and avulsed channel area looking west, 14 Nov 2016 (hummocks in easement along fence on right side of photo).

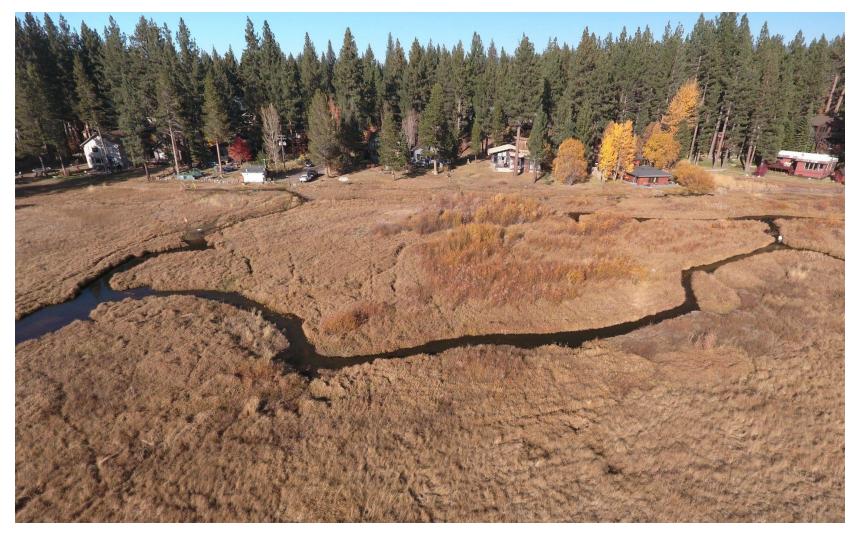
In November 2020, NHC staff resurveyed cross sections, collected repeat photographs and flow measurements, and made general monitoring observations of the Bellevue site per the monitoring plan (Table 4-1). Initial impressions included increased vegetative growth (willow and herbaceous; Figure 4-18) and an almost completely inundated easement (Figure 4-19). The vegetation monitoring summary (Appendix D) indicates that vegetation establishment has been successful in the abandoned road fill and the AMP features. Northwest Territory sedge (Carex utrichulata) dominate much of the area and planted willow stakes (noted in 2015 monitoring to not meet construction performance requirements) are now 5 to 8 feet tall. The WSEs in the easement were generally about one foot higher than the WSEs along the primary flow path down Trout Creek and PC-3 (Figure 4-20). The primary source of water in the easement flows from upstream, where water is spilling onto the floodplain near BV-22, which is in part due to the network of primary and secondary beaver dams upstream of the Bellevue project area. Given the elevated groundwater levels since 2017, it is possible that some of the water on the easement comes from seepage into the marsh from adjacent upland areas, as anecdotally suggested by the water level being higher at MW-4 than the adjacent downstream water level at TC 001, and in some cases higher than the mid-stream water level at TC 002 (Figure 4-2). The water entering the overbank makes its way downstream through the easement until it reaches the previous Trout Creek alignment and flows back into Trout Creek (refer to Figure 4-13). The 2018 LiDAR micro-dendritic pattern of flow paths in the overbank as opposed to the 2010 LiDAR, which perhaps suggests that flows are being concentrated along the easement (Figure 4-8), however, significant concentration of flows was not observed in the field.

Figure 4-18. Oblique aerial image looking north across the project site, photo taken 5 November 2020.

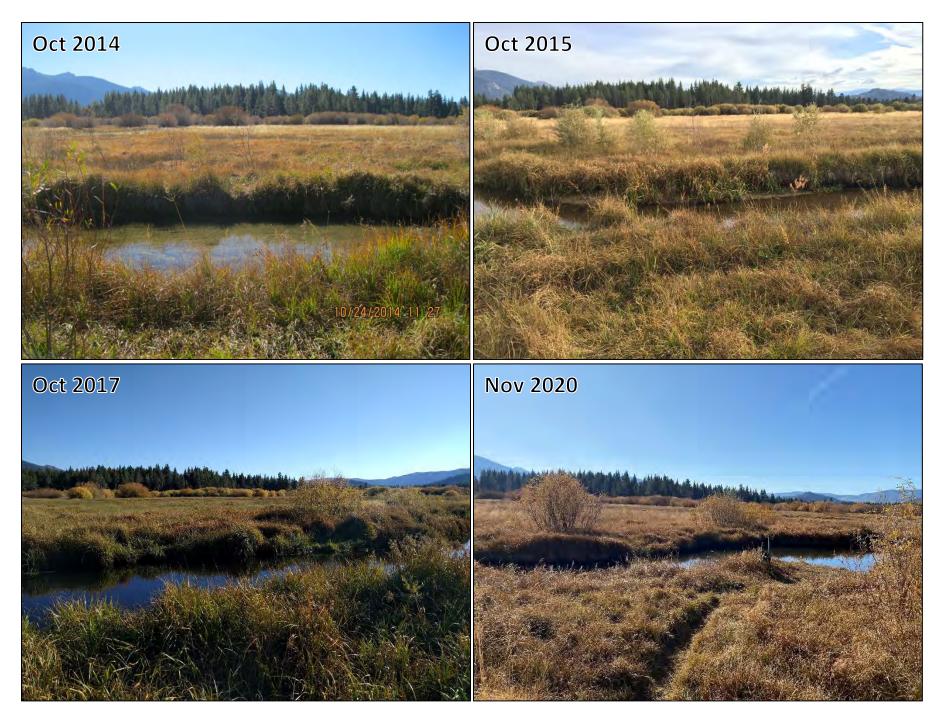
TMSFPP AMP Closeout – Photo Point 6 – Looking southwest across marsh towards Trout Creek near downstream end of Bellevue Avenue project area

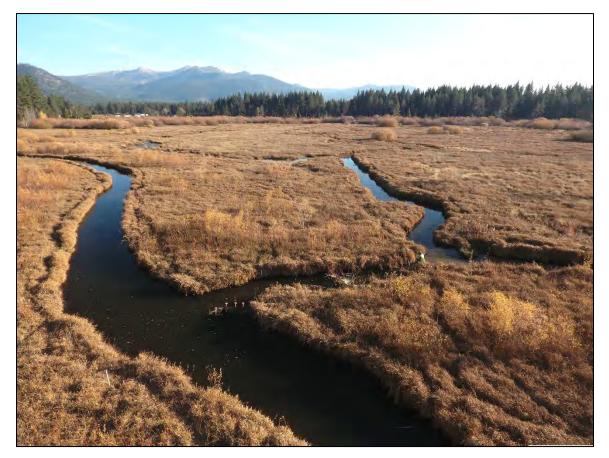
Beaver activity upstream of the Bellevue work area increased in 2017, resulting in long duration overbank flooding of the District's easement and several of the manholes on the gravity sewer. The increase in flooding in 2017 appears to be related to construction of an extensive system of auxiliary beaver dams on flow paths that would otherwise return overbank flows to the main channel. The blockage of these return flows causes overbank flows near the District's Manhole BV-22 to continue down the right overbank and flood other manholes in the easement. Several areas of ponded water were evident in this area in August 2017, including areas near Manholes 18, 19, 21, and 22. Beaver activity in the main channel resulted in sediment deposition in the main channel upstream and at the location of the Pond Leveler installed in October 2016. Sediment deposition upstream of the pond leveler reduced main channel capacity and increases left and right overbank flows. Right overbank flows generally accumulated near the District's manhole BV-22 because auxiliary beaver dams along the banks of the channel limit flows from re-entering the main channel. A second dam on the main channel was also noted in 2017, close to BV-22.

View upstream of flow deflector - note surveyor standing at downstream end of beaver dam for scale

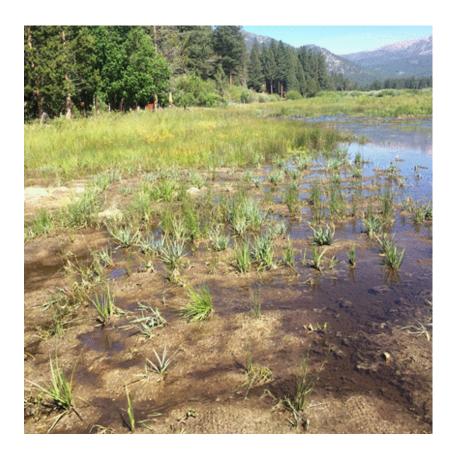
Photo 3. June 23, 2105

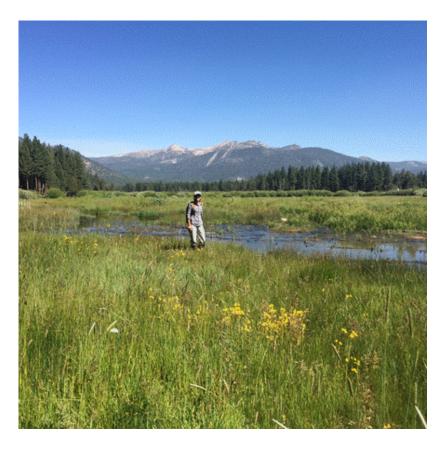
Photo 4. June 23, 2015

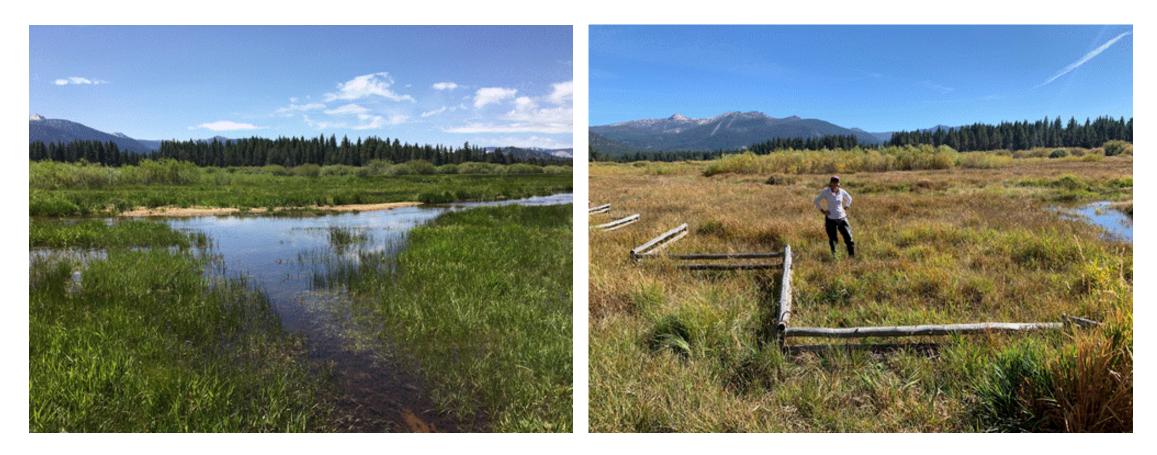
Photo 9. May 31, 2018

Photo 10. Hummock 1, September 25, 2020

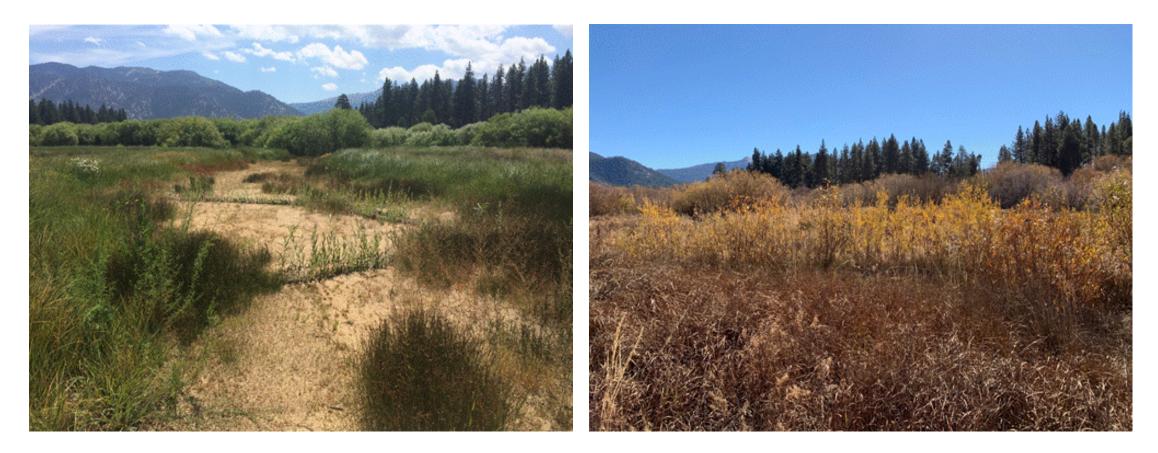
Photo 14. July 17, 2015

Photo 15. October 29, 2020

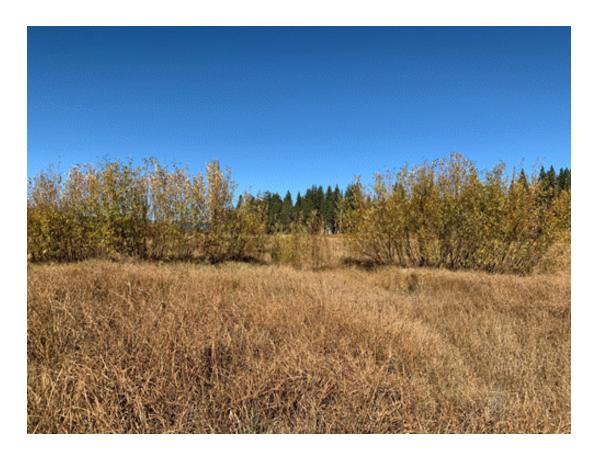
Photo 16. October 29, 2020

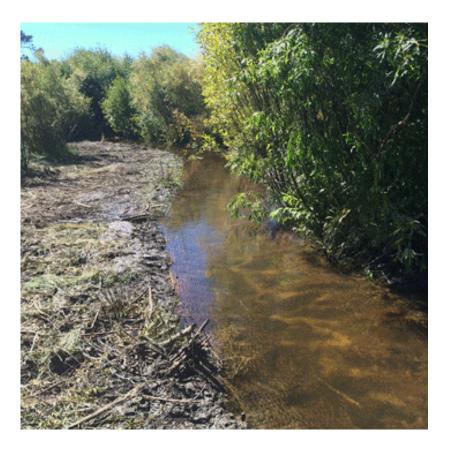
Photo 18. August 27, 2015. Hand clearing vegetation at Trout Creek to direct flows away from the pipeline ROW. Bare soils were seeded

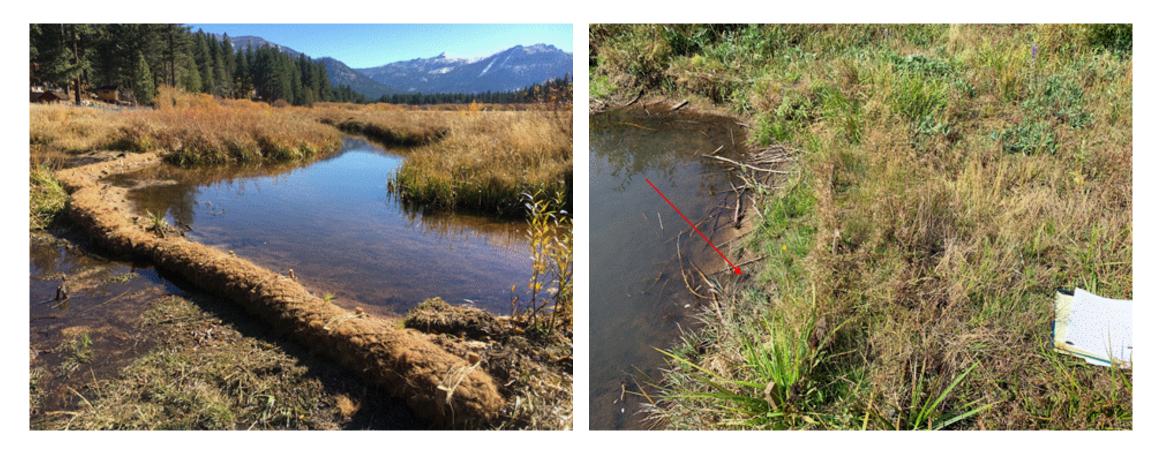
Photo 19. Coir log installed at Hummock 4 November 2, 2016

Photo 20. Well-vegetated coir log at Hummock 4, September 11, 2020

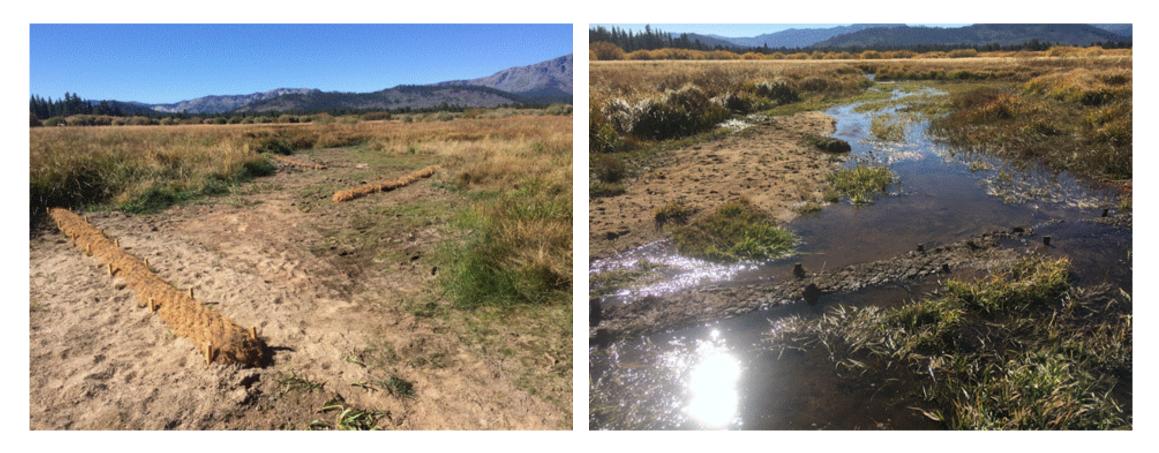
Photo 21. Coir log install year 2, September 17, 2015 near Hummock 1

Photo 22. October 26, 2016

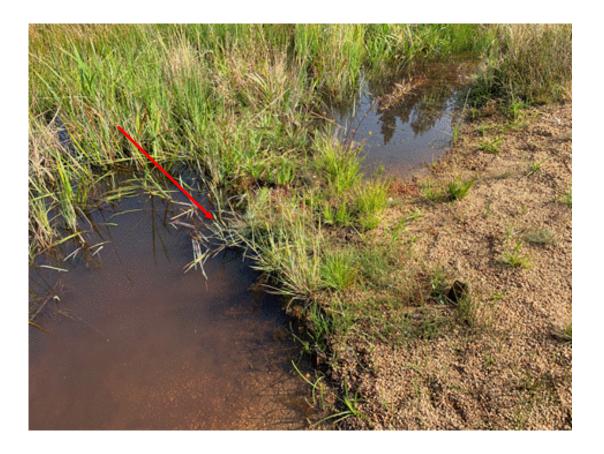
Photo 23. Vegetated coir log near Hummock 1, September 11, 2020

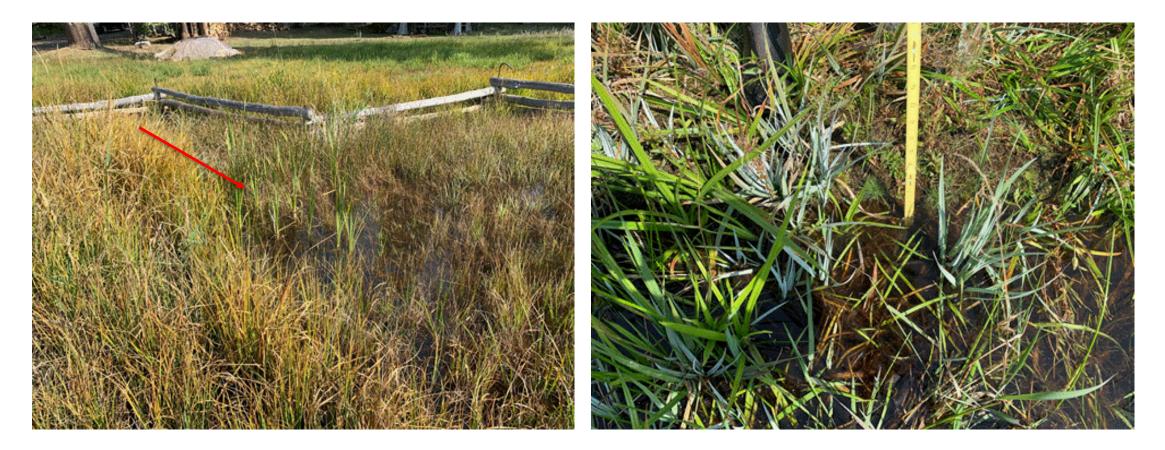
Photo 24. Colonizing cat tails, September 11, 2020

Photo 25. Six-inch depth from surface of hummock to surface of open water, September 11, 2020. Note persistence of planted *Carex nebrascensis* (blue) and establishment of *Carex utriculata*

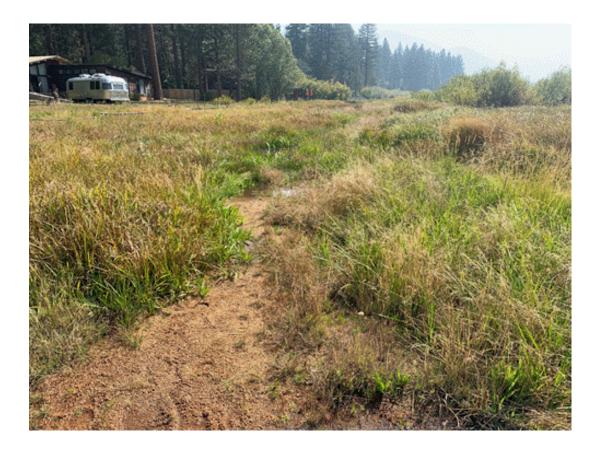
We observed deposition by coarse sand in numerous locations.

Photo 26. Coarse sediment deposition, September 11, 2020
