UPPER TRUCKEE MARSH SEWER FACILITIES ADAPTIVE MANAGEMENT PLAN

2017 ANNUAL REPORT

South Tahoe Public Utility District

Northwest Hydraulic Consultants Inc.

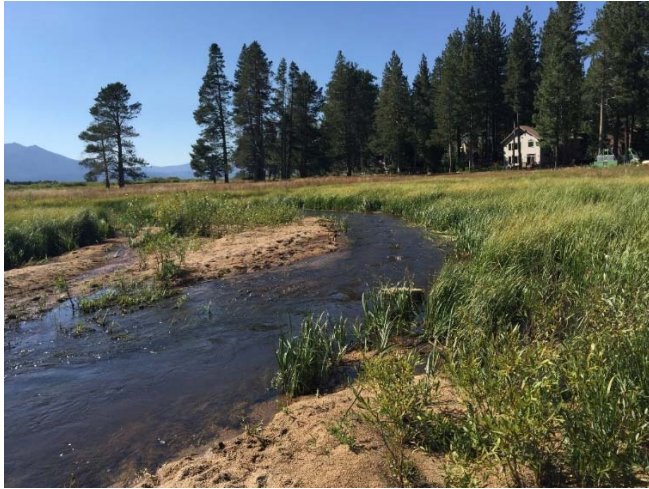
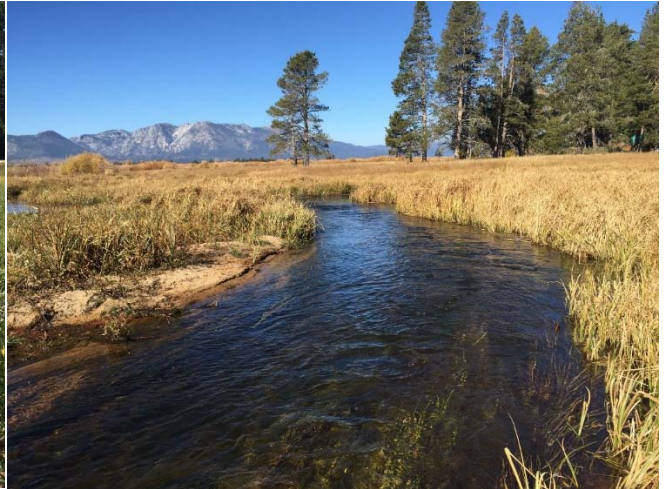
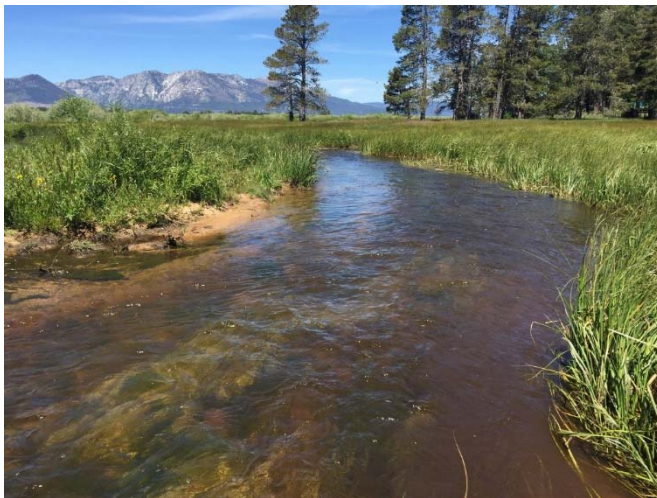
In addition to increased flow capacity, active bed load transport and bed form development (scour, ripples, dunes) were evident in the pilot channel system. The main pilot channel beds are now observed

to have little vegetative growth and are characterized by sand in gradual transport along the bed. Figures 4-3, 4-4, and 4-5 show pilot channel conditions in August 2016, October 2017, and June 2018.

Figure 4-3. Pilot channel flow looking downstream approximately 100 feet upstream of confluence with Trout Creek showing overbank deposition of sand during high flows on 9 Aug 2016 and expansion of channel on 18 October 2017 and 22 Jun 2018

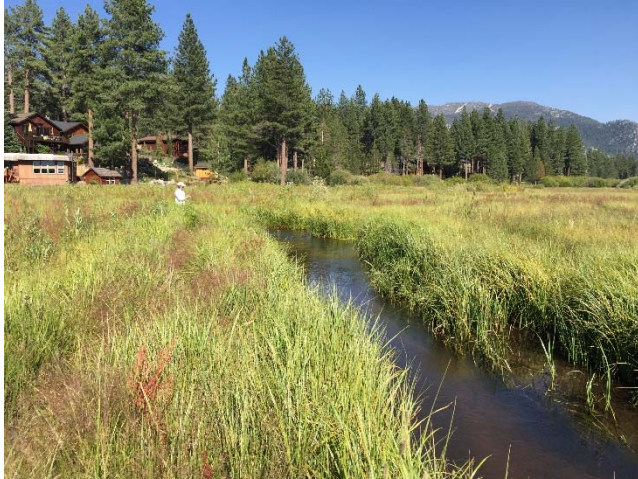
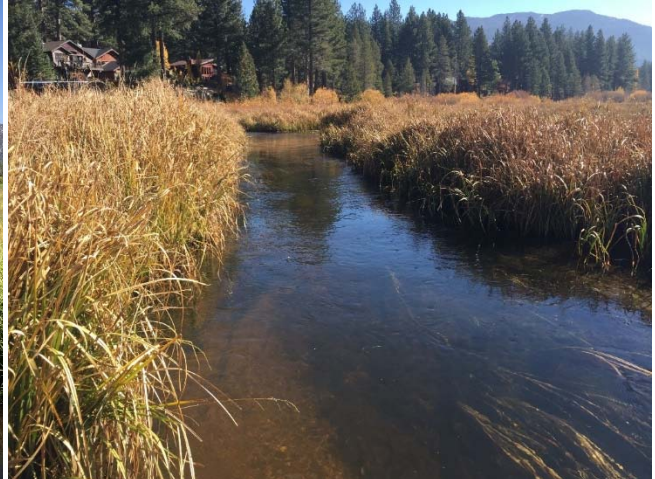
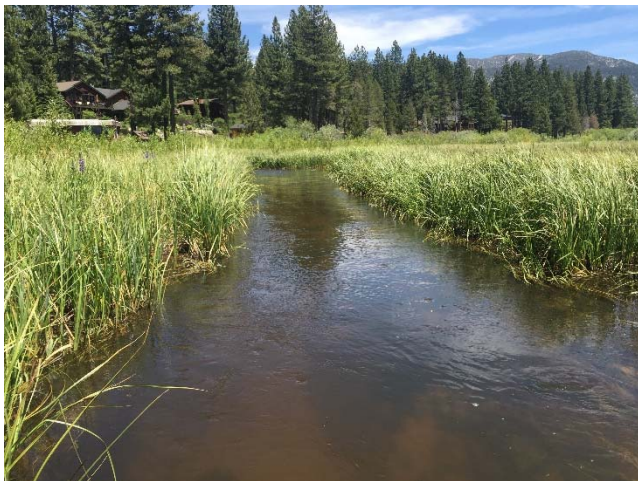
Figure 4-4. Pilot channel (PC-3) middle portion looking upstream on 9 August 2017, 18 October 2017, 22 June 2018 showing modest channel development

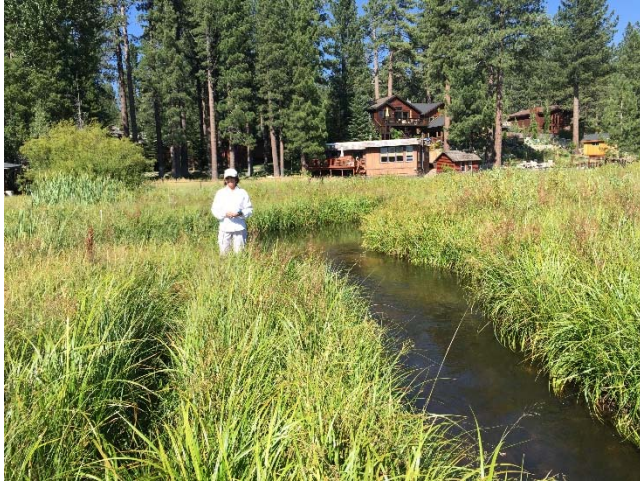
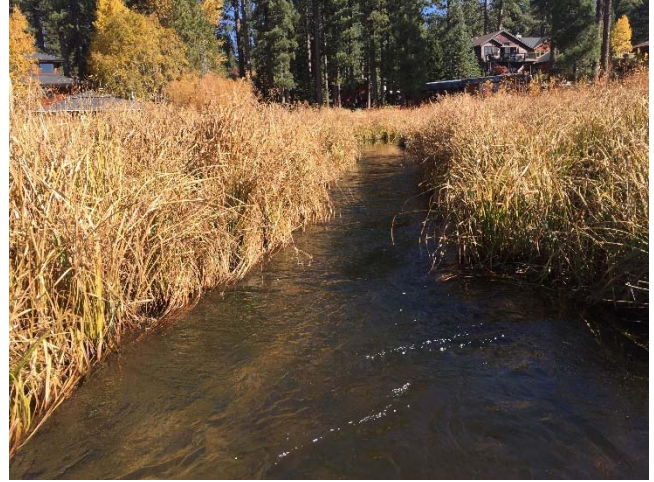
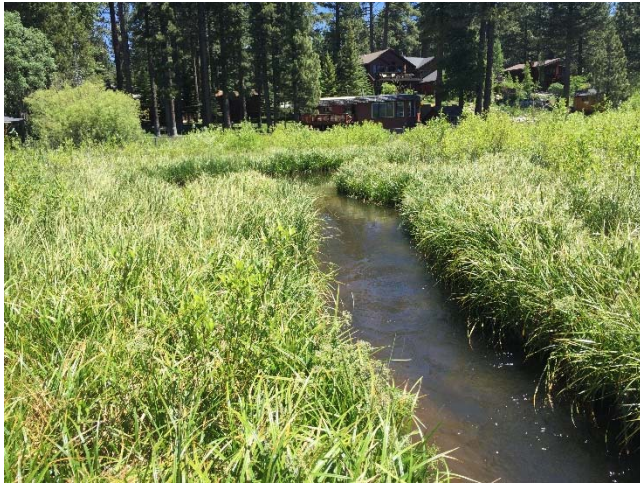
Figure 4-5. Pilot channel (PC-3) upper portion looking upstream on 9 August 2017, 18 October 2017, 22 June 2018 showing little change in channel width

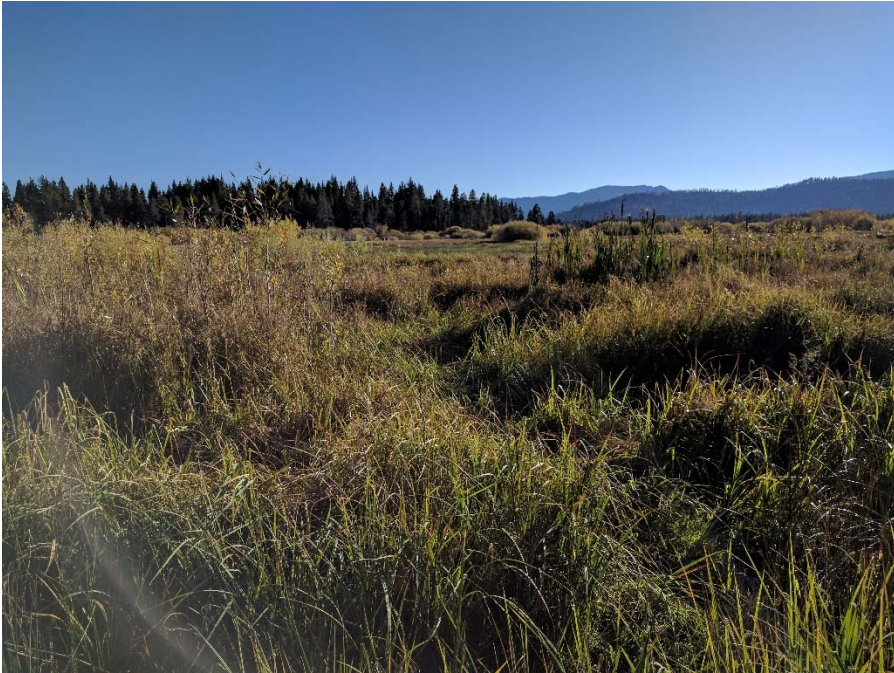
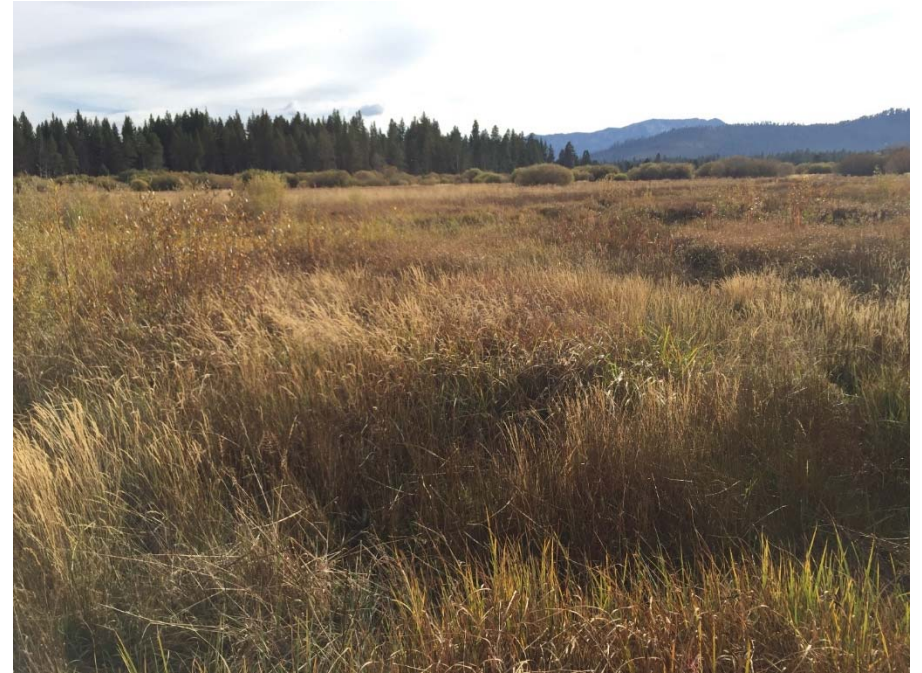
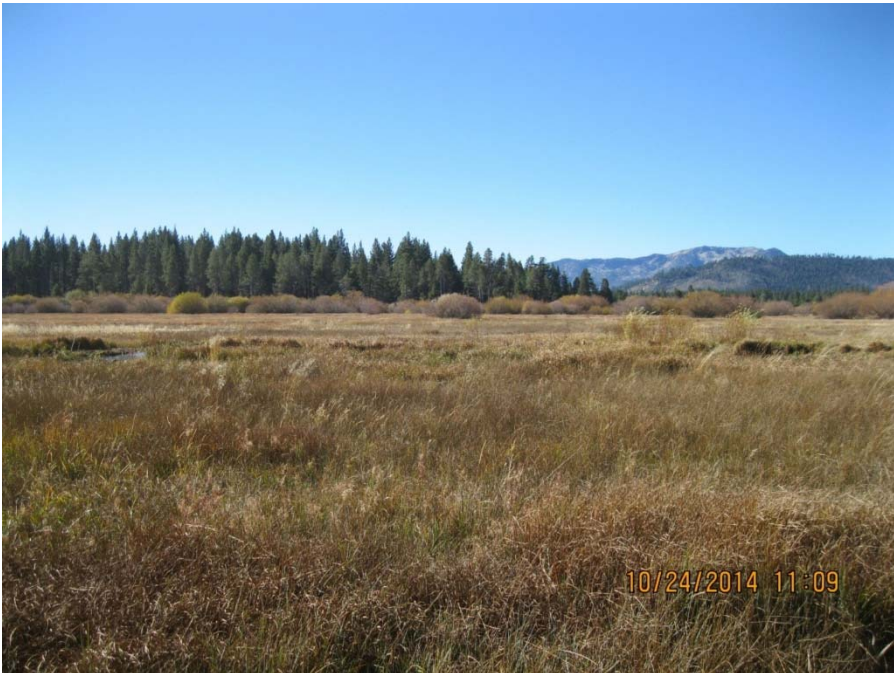
Photo Point 1 – Looking SW across right overbank

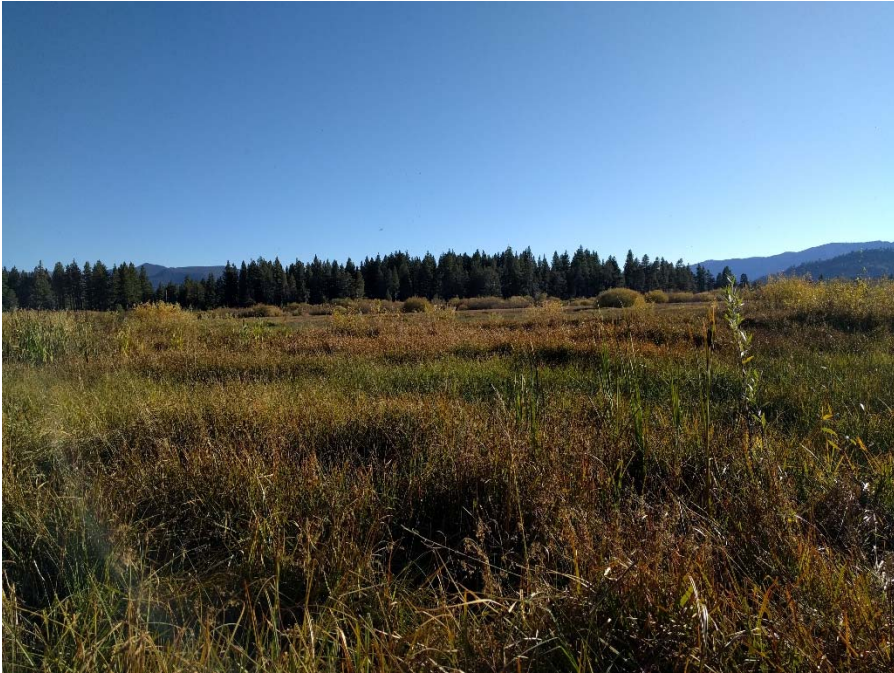
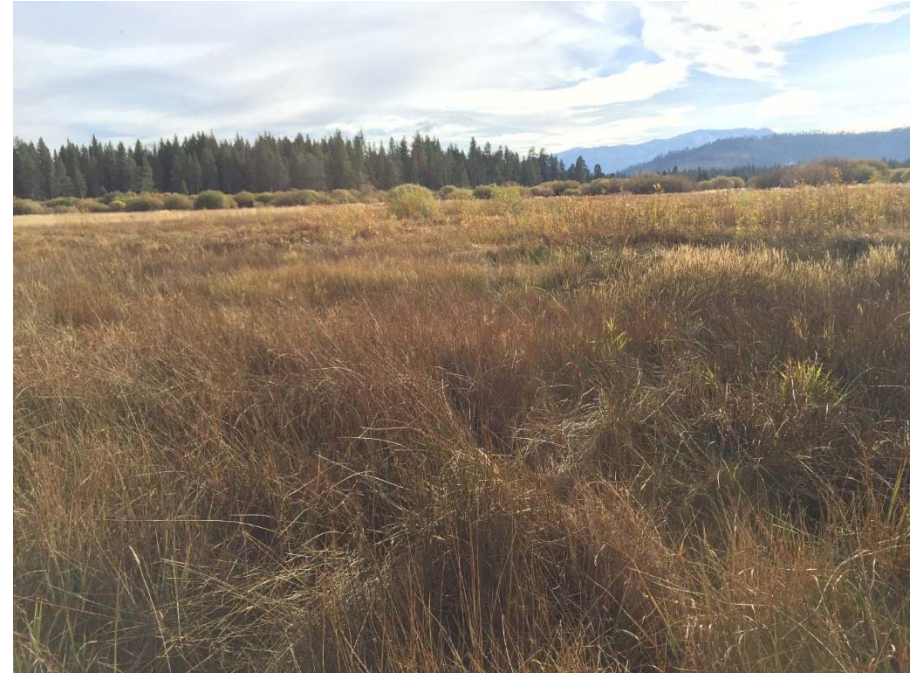
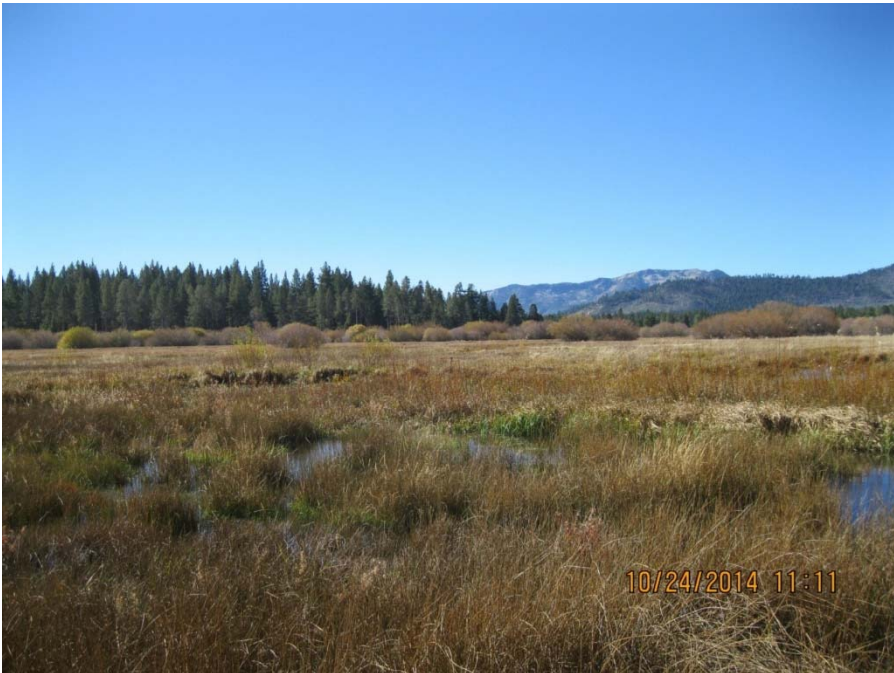
Photo Point 2 – Looking SW across right overbank

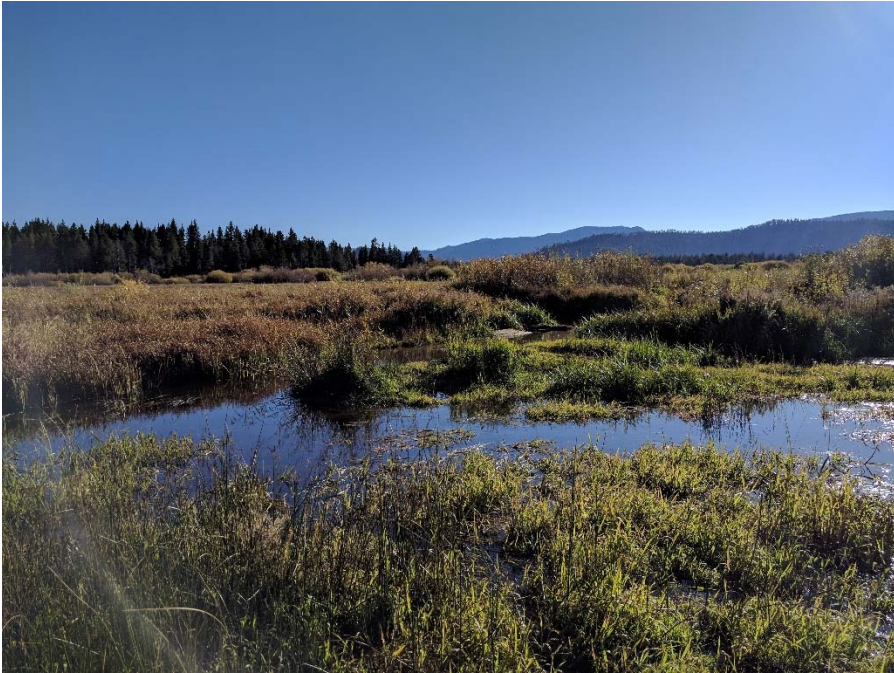
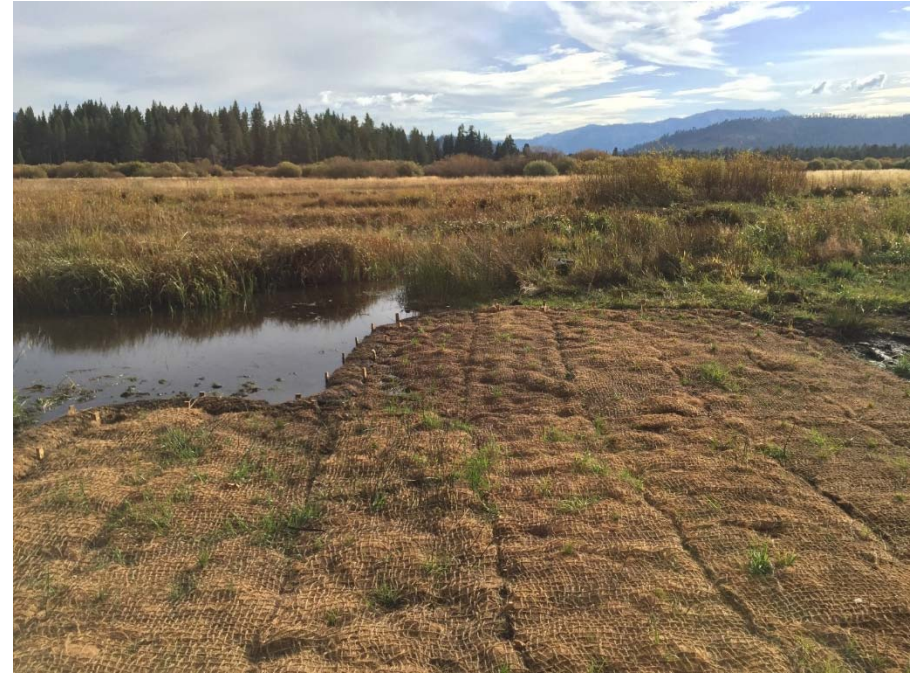
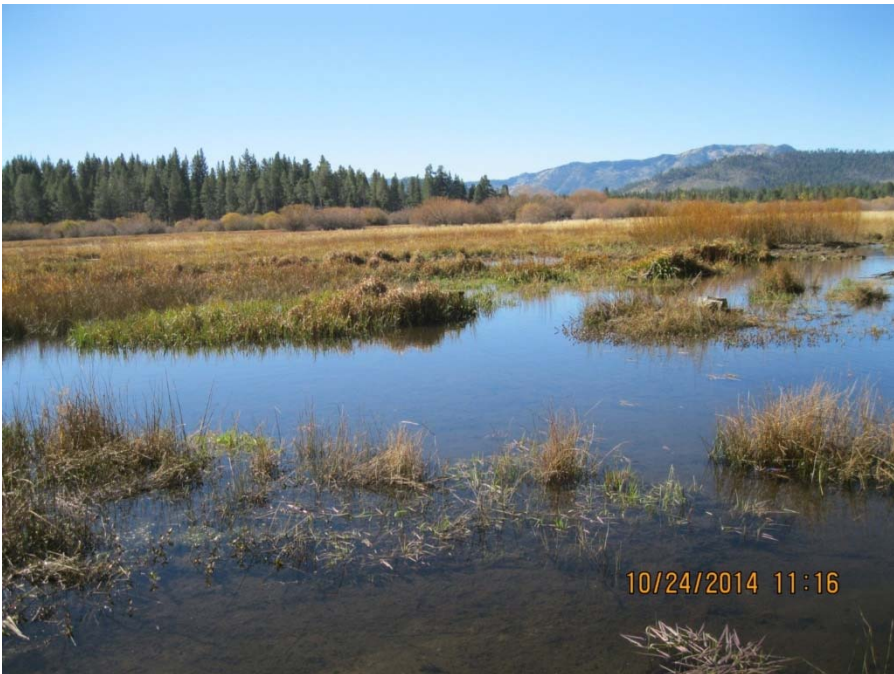
Photo Point 3 – Looking SW across right overbank in avulsion area;
LBO-1 at middle far right of view, FH-5A in foreground

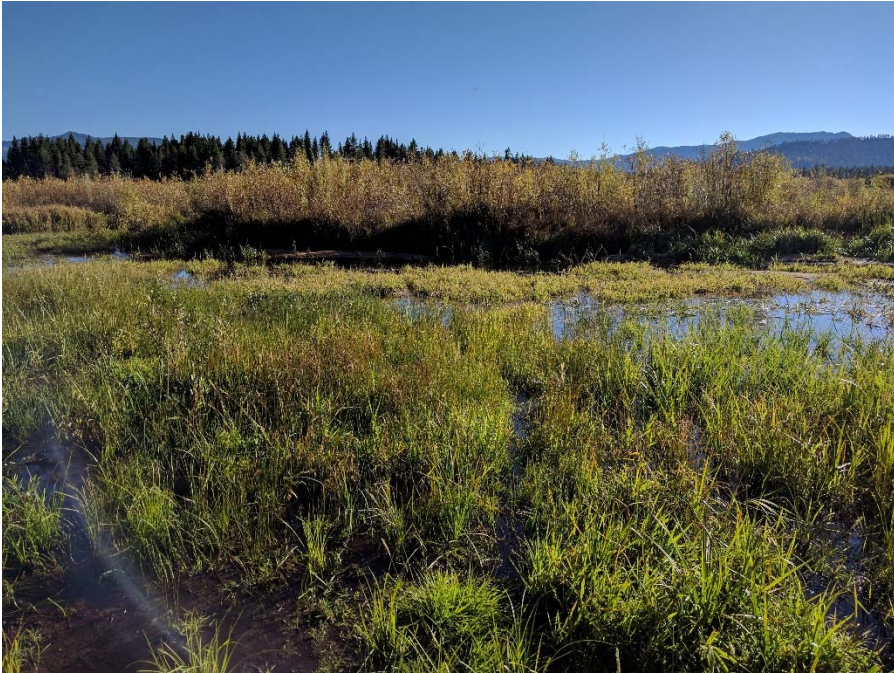
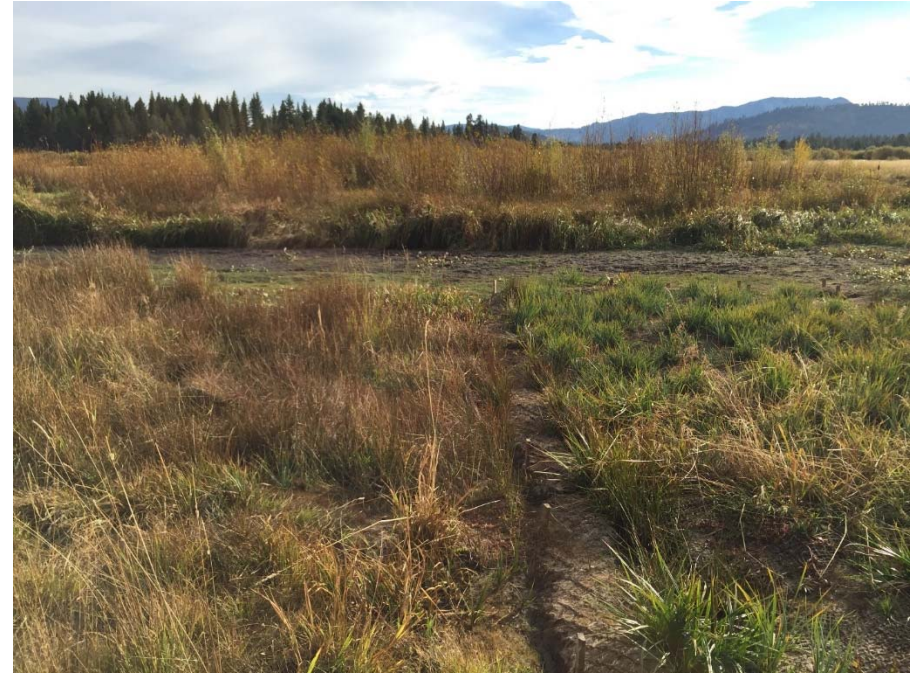
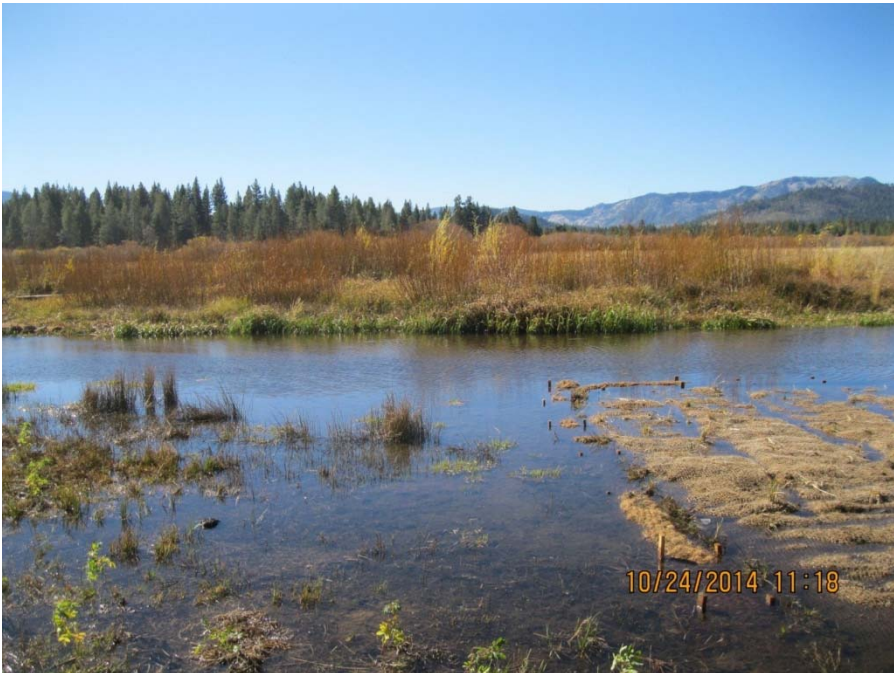
Photo Point 4 – Looking SW across right overbank in avulsion area; FH-3 at lower right

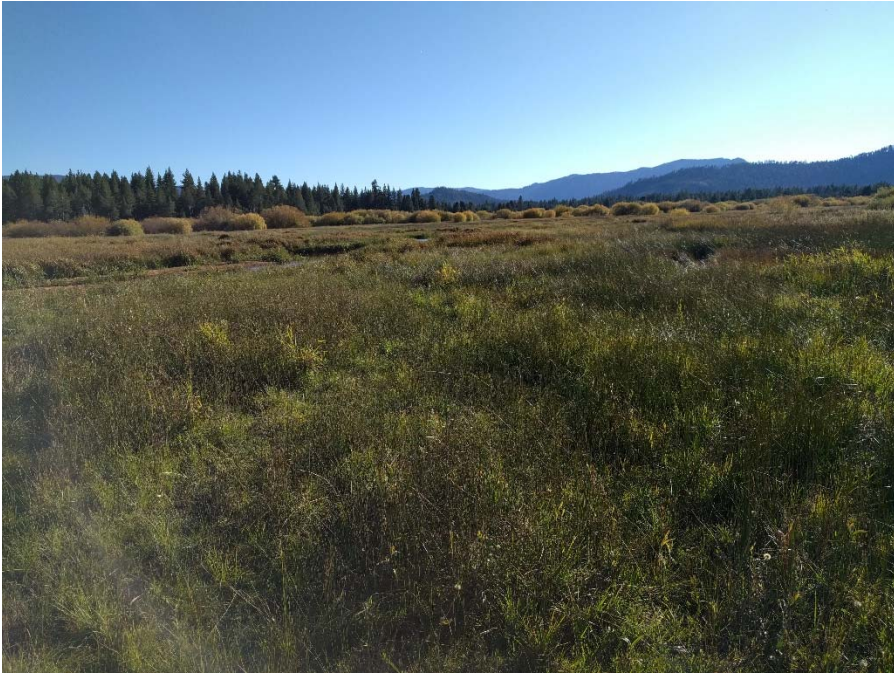
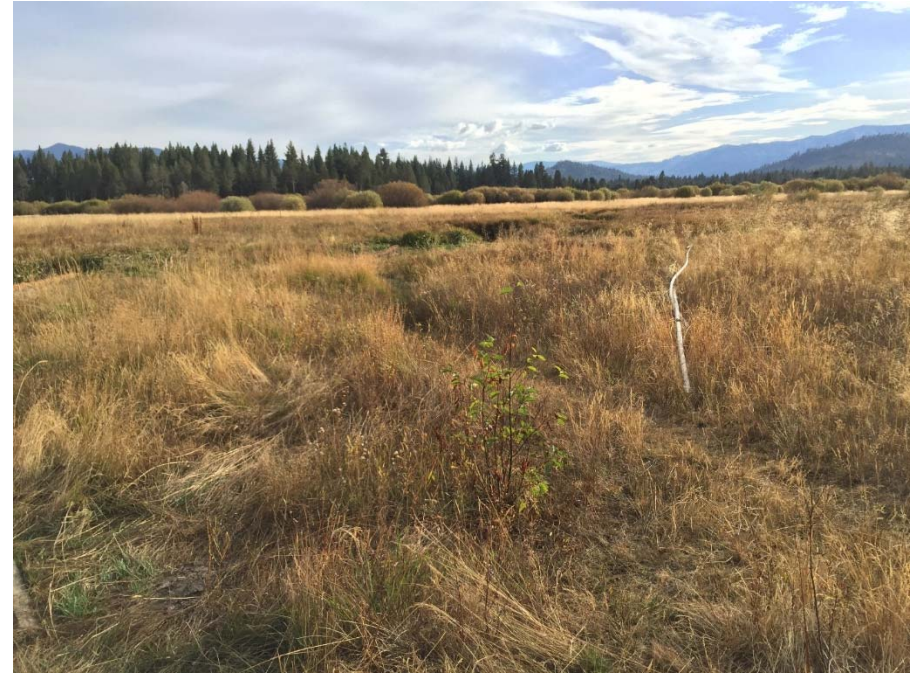
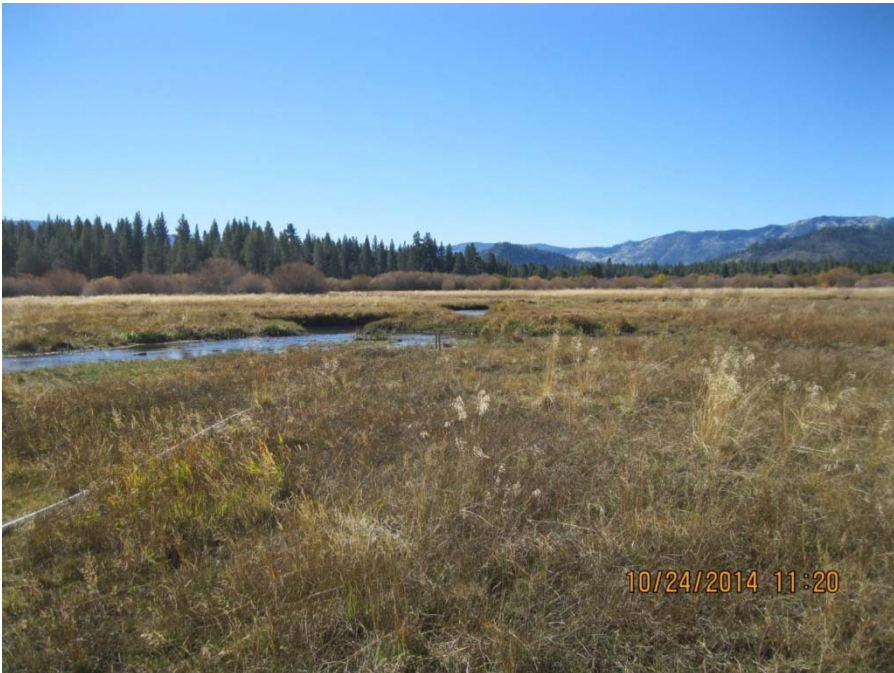
Photo Point 5 – Looking SW across right overbank at downstream end of avulsion area

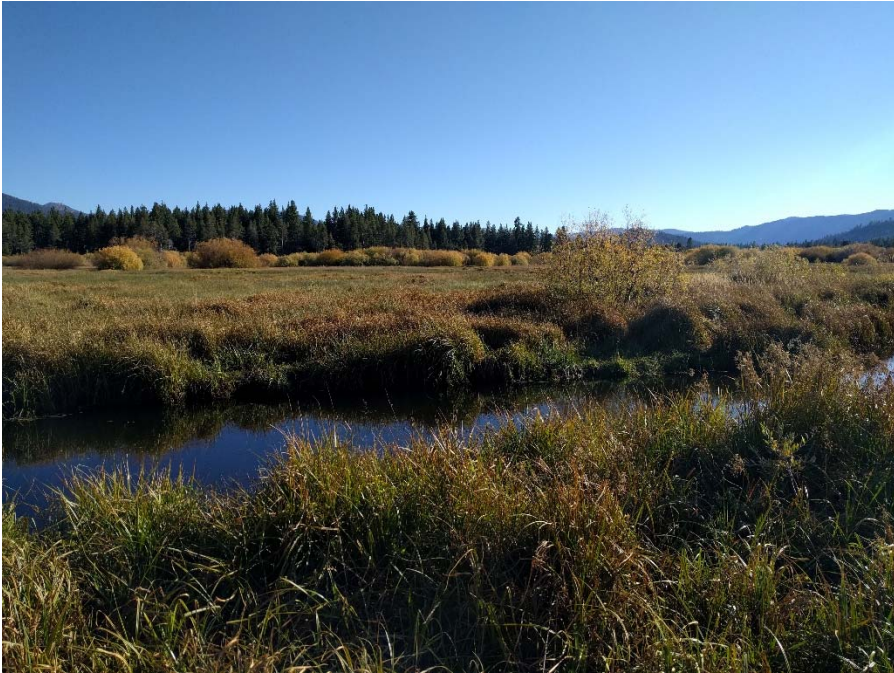
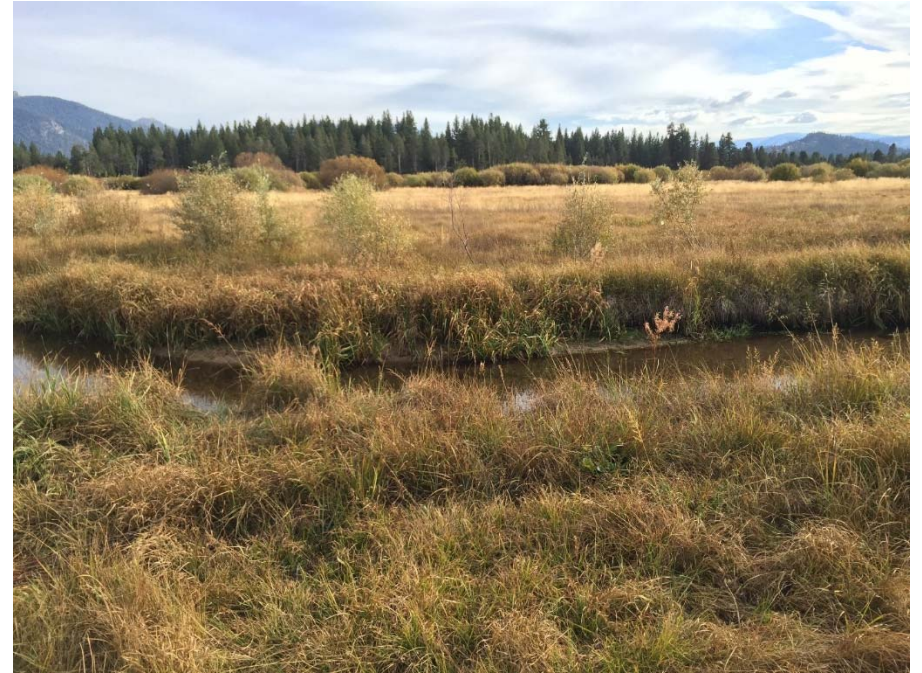
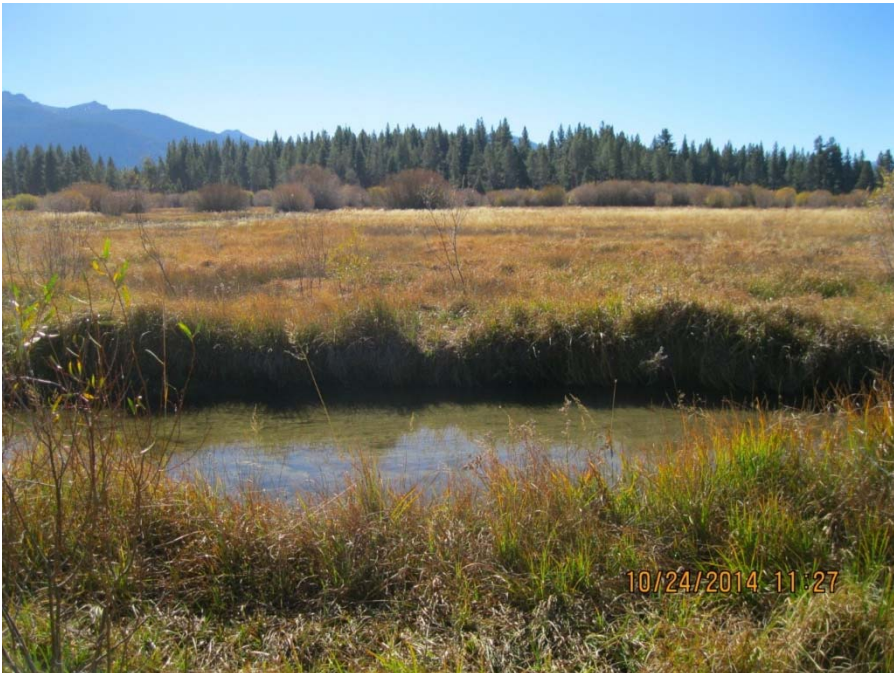
Photo Point 6 – Looking SW across marsh towards Trout Creek, near downstream end of project area near Bellevue Avenue

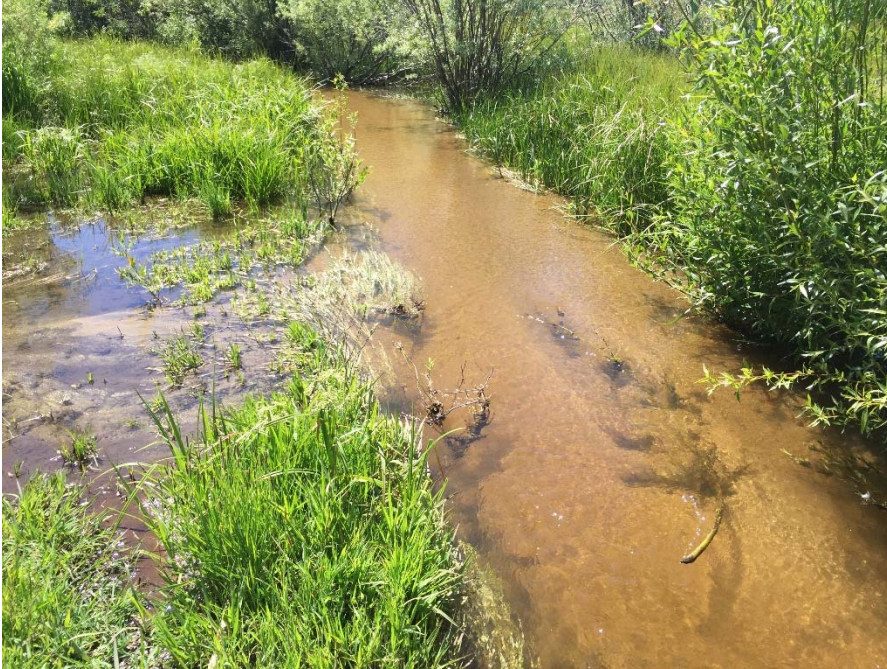
Sand in secondary channel
near head due to beaver
dams downstream
